JTC Engineering Investigation

Water Transfer Tubes Crack along Welded Joints, Causing a Leak

Investigation Leader: Jessica Nicholson

Date Opened: 6/21/2021

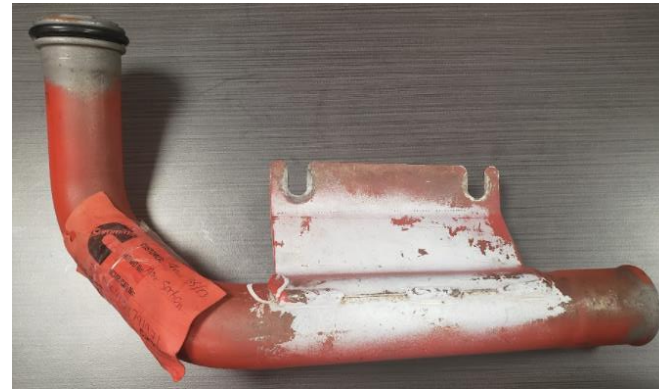
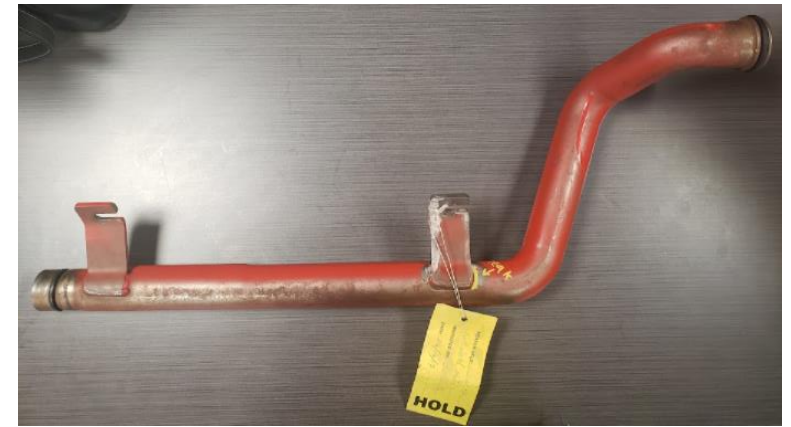
- Fail Code: KCTA
- Both parts crack along weld joint connecting bracket to tube
- Crack can get worse and lead to failure if not identified and fixed
- Leaks are commonly reported along this crack

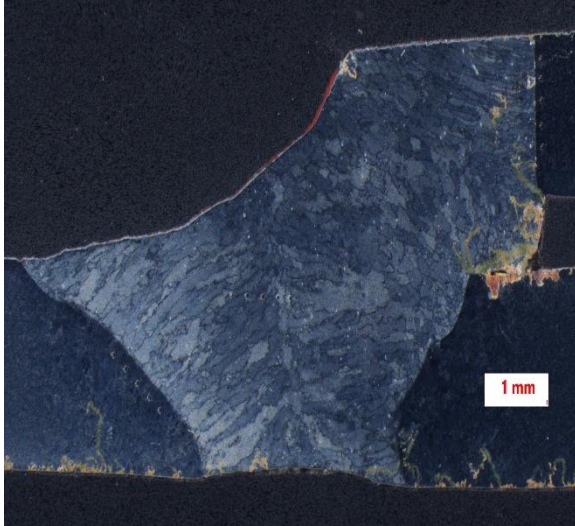
Failed Tube #1

- Throat size = 1.769 mm
- Excess weld penetration
- Weld root concavity
- Porosity > 1.5%
- Bracket-tube clearance

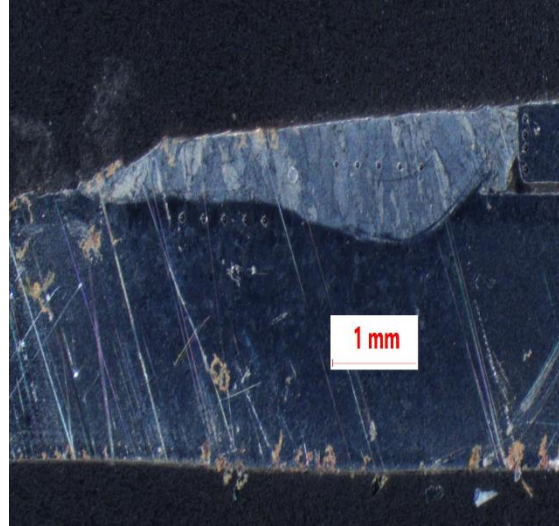
Failed Tube #2

- Lack of fusion, bracket side
- No throat size due to this
- Porosity > 1.5%
- One large gas pore, 0.135 mm

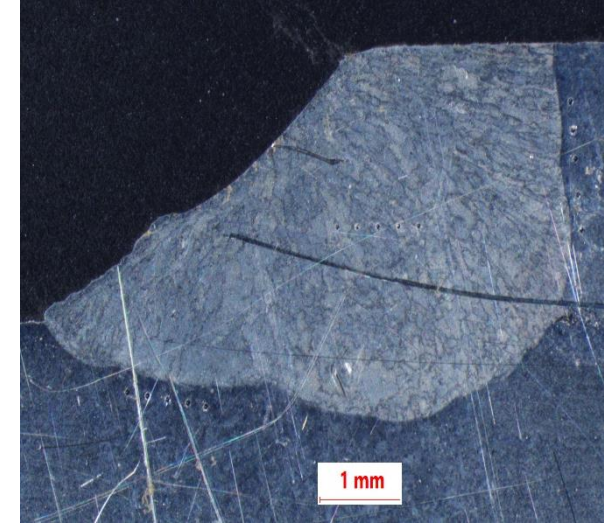
New Tube

- Throat size = 2.355 mm
- Porosity > 1.5%

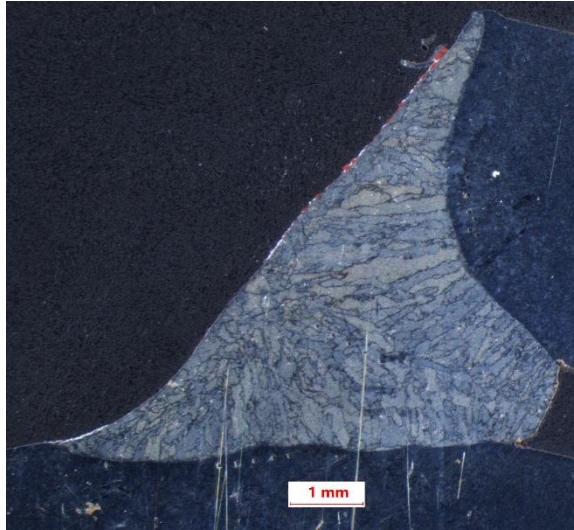
Failed Tube #1

- Throat size = 3.19 mm
- Porosity > 1.5%
- Bracket-tube clearance

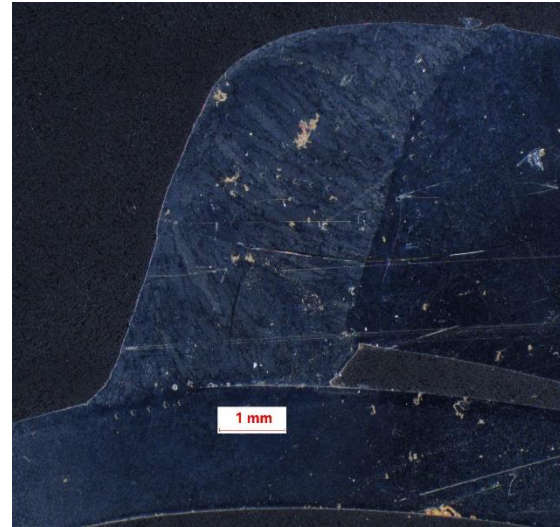
Failed Tube #2

- Throat size = 2.678 mm
- Porosity > 1.5%
- Gas pores, HAZ tube side
- Size range = 0.05 - 0.138 mm

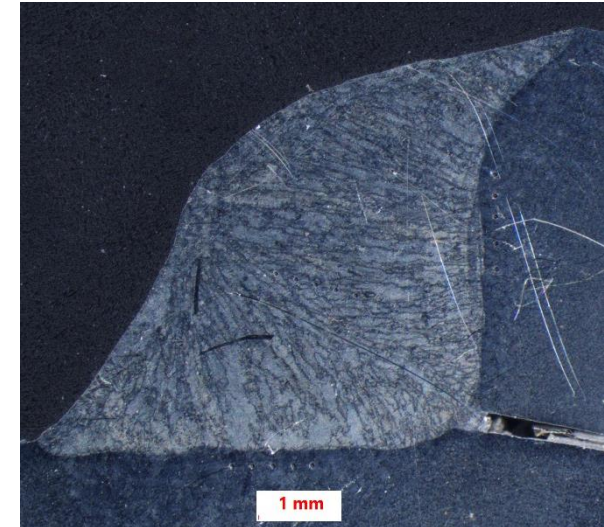
New Tube

- Throat size = 4.176 mm
- Porosity > 1.5%

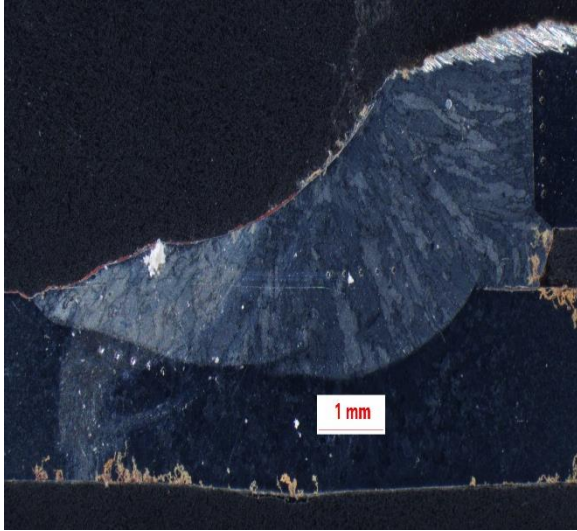
Failed Tube #1

- Throat size = 1.985 mm
- Porosity > 1.5%
- Small gas pores
- Largest gas pore = 0.122 mm
- Undercut on the left toe

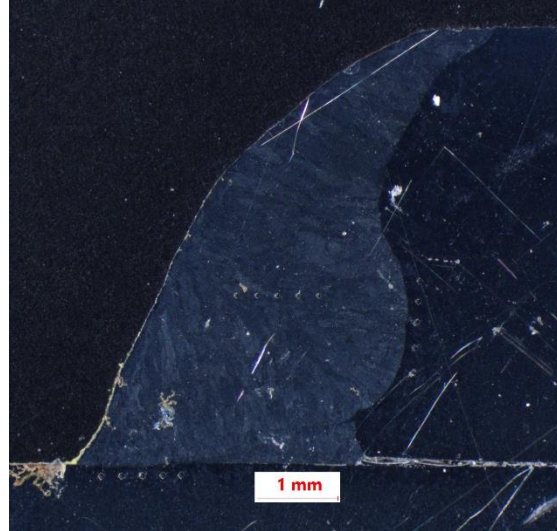
Failed Tube #2

- Throat size = 3.131 mm
- Porosity > 1.5%
- Small gas pores

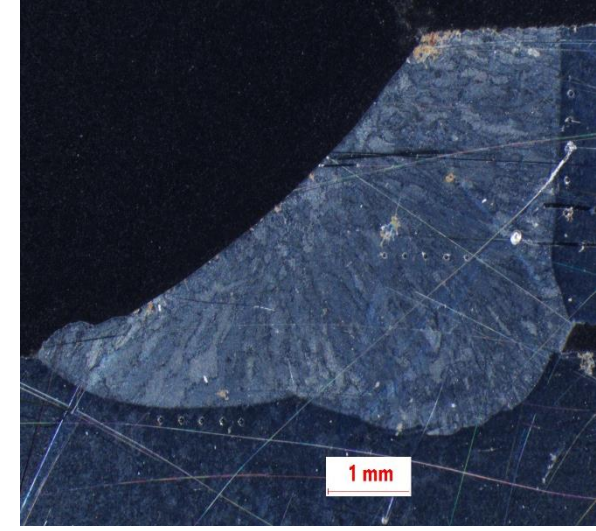
New Tube

- Throat size = 2.803 mm
- Porosity > 1.5%
- Single gas pore, 0.184 mm

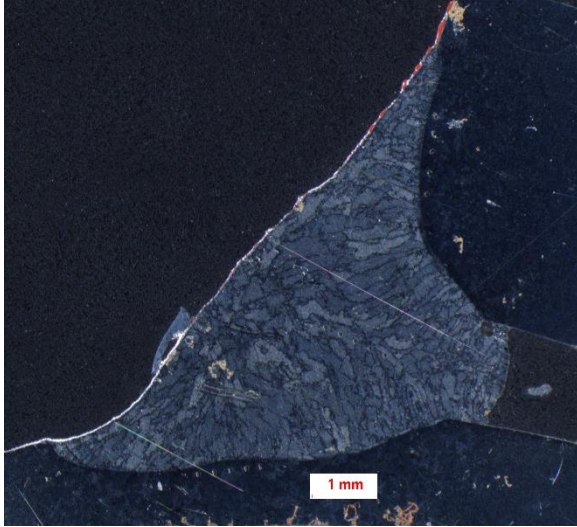
Failed Tube #1

- Throat size = 2.575 mm
- Porosity > 1.5%
- Lack of root fusion
- Small gas pores
- Largest gas pore = 0.218 mm
- Bracket-tube clearance

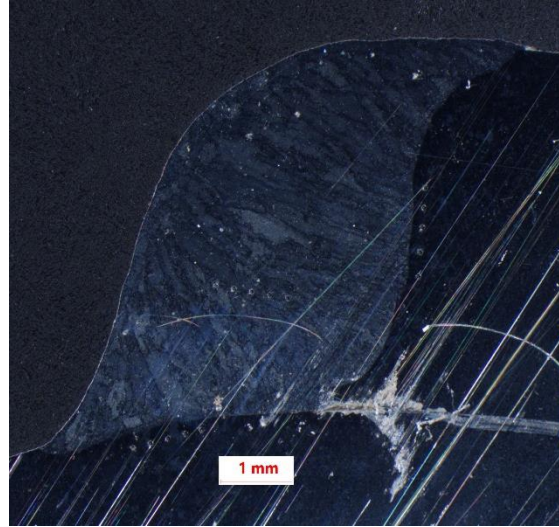
Failed Tube #2

- Throat size = 2.629 mm
- Porosity > 1.5%
- Small gas pores
- Bracket-tube clearance

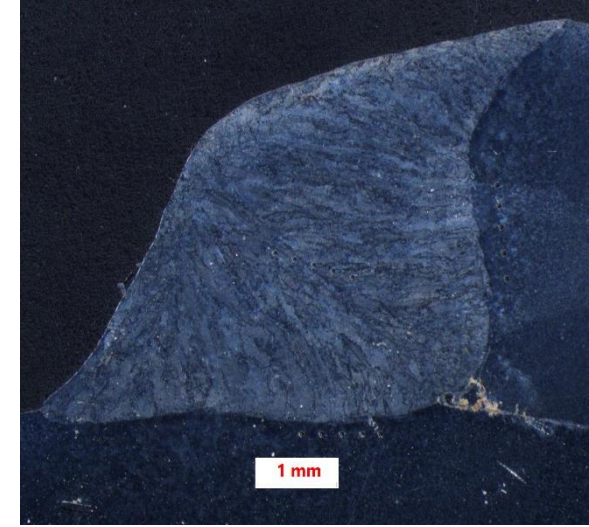
New Tube

- Throat size = 4.184 mm
- Little weld porosity

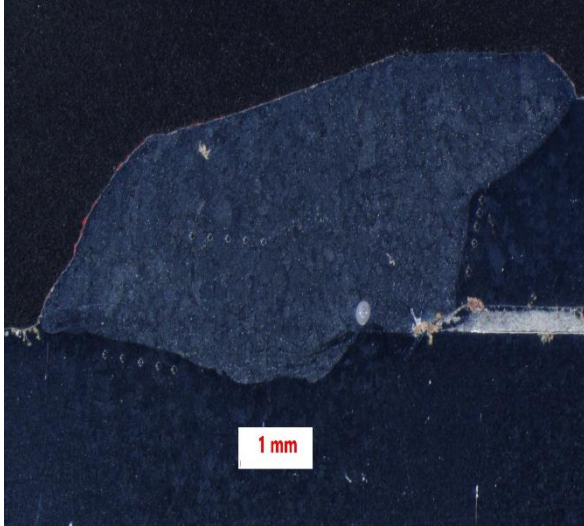
Failed Tube, Location A

- Throat size = 2.251 mm
- Porosity > 1.5%
- One gas pore, 1.248 mm
- Slight undercut on left toe

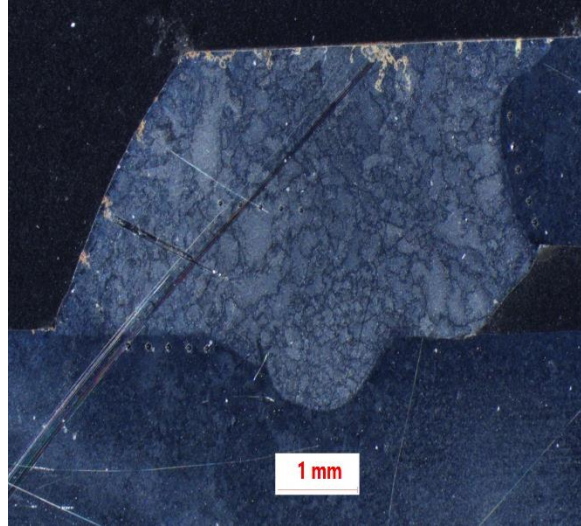
New Tube, Location A

- Throat size = 1.813 mm
- Little porosity
- Small gas pores
- Bracket-tube clearance

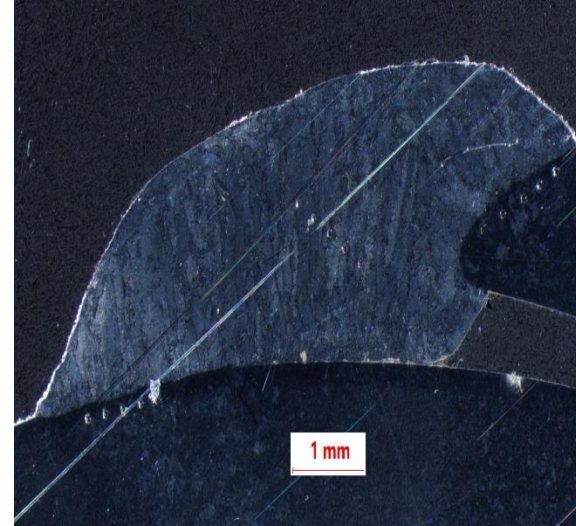
Failed Tube, Location B

- Throat size = 1.914 mm
- Porosity > 1.5%
- Bracket-tube clearance

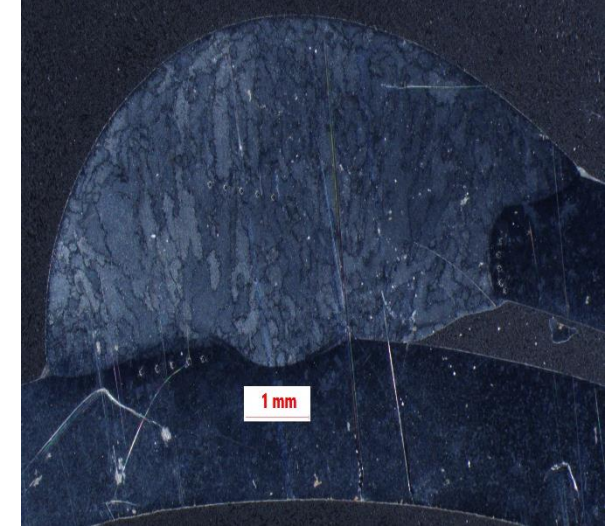
New Tube, Location B

- Throat size = 2.101 mm
- Little porosity
- Small gas pores
- Bracket-tube clearance

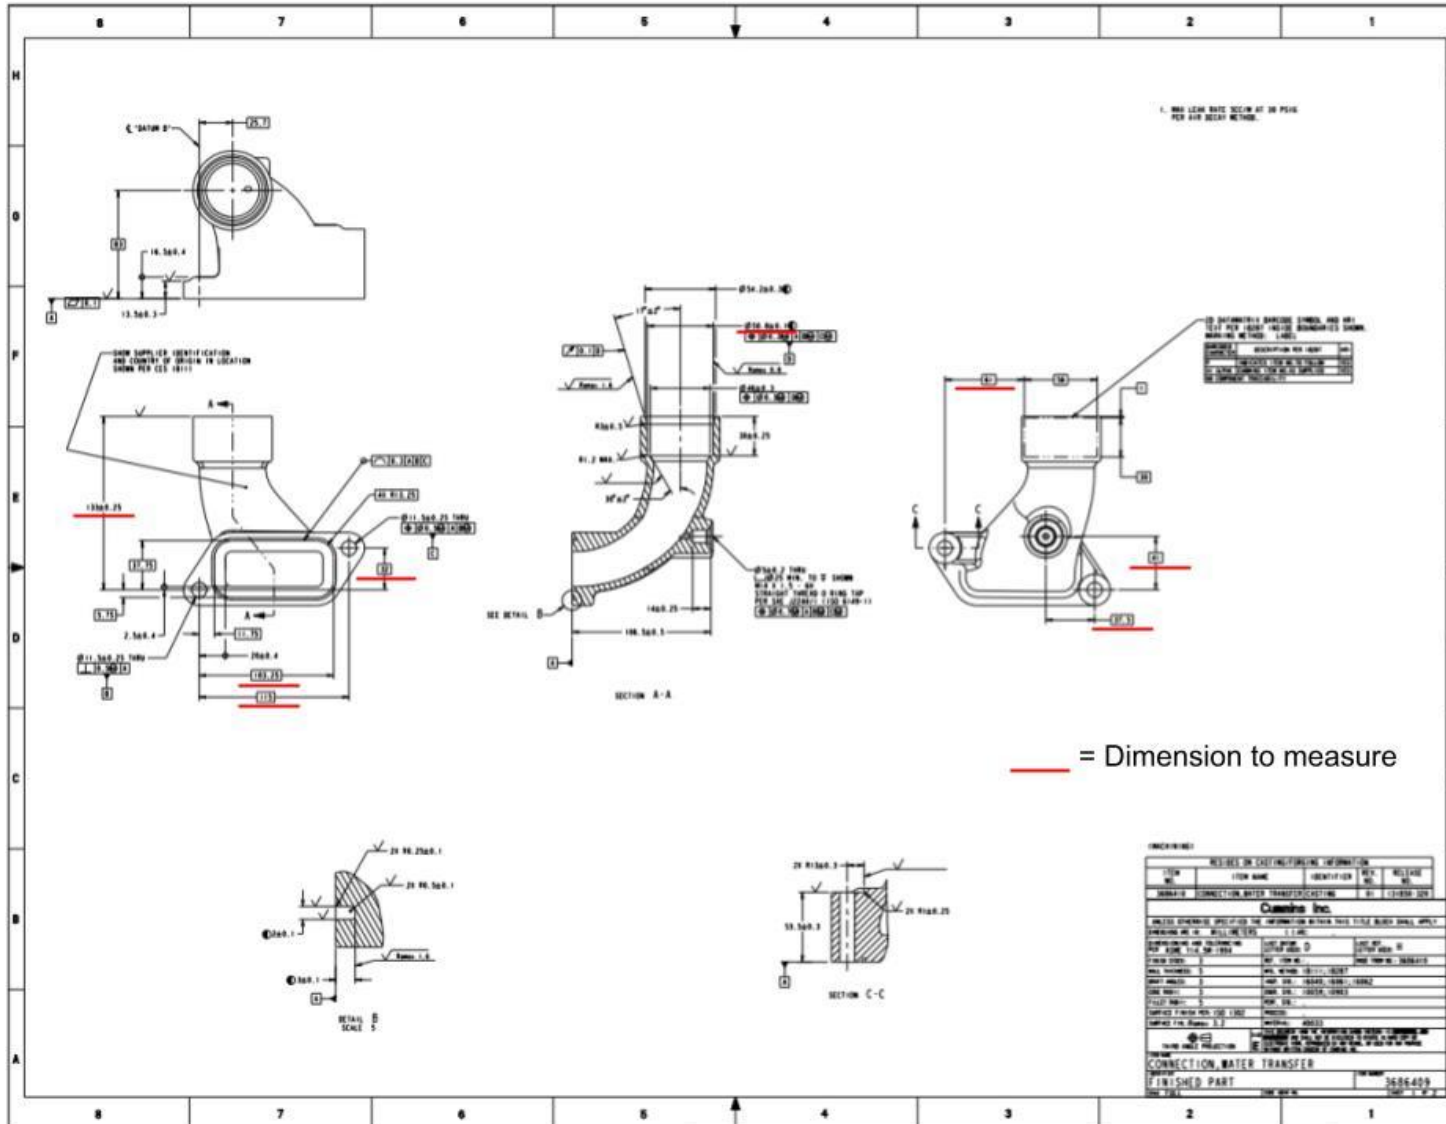
- Dimensional issues commonly found in these connector parts
- 4 samples chosen with visually-evident machining and dimensional errors
- Dimensions shown measured for each sample
 - Evaluated conformance to print tolerances
 - Determined significance of dimensional variation

- Measurement failures that have an impact on pipe fit and internal stress
 - Datum C position deviates in the x direction
 - Distance from datum B to end of tube fit significantly varies
 - Distance from datum B to end of tube fit variation (Nominal = 103.25 mm)
 - These three dimensions have an impact on the x-direction fit of the connector
 - Any connector fit deviation translates to the fit of the pipe within the connector
 - Datum D position variation
 - This position affects the horizontal x-y location that the pipe fits to the connector
 - Distance from datum B to top of connector
 - If this dimension is too long, it may push pipe upward (z-direction)
- These dimensional errors found in the 3686409 connector **are** a likely cause of failure due to internal stress caused by imperfect fit

- Connector supplier: [REDACTED]
- 3 hydraulic and 1 manual clamping mechanism in each CNC machine
- Manual clamping mechanism identified as cause of dimensional issues
- Replaced manual clamping mechanism with hydraulic clamping mechanism
- Should significantly reduce error in positioning from manual mechanism
