End of Co-op Presentation

By: Jessica Nicholson

Water Transfer Tube Weld Cracking Investigation

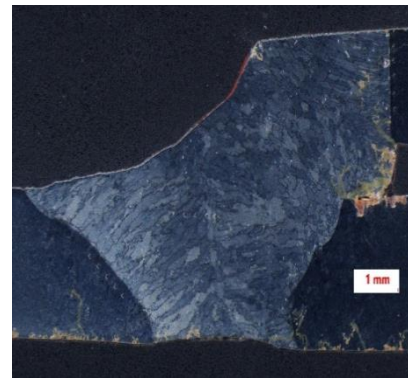
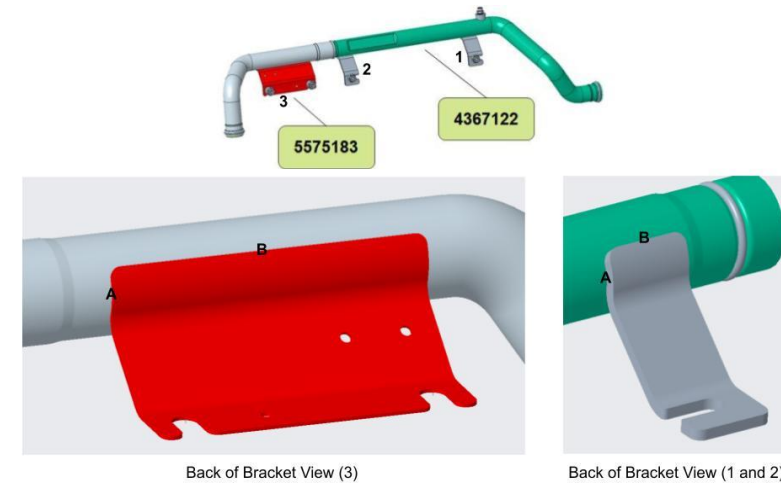
- Inspected weld properties in failed and new samples
 - ISO 5817 standards used to evaluate weld properties
 - Cross-section cut to evaluate each weld
- Evaluated properties: Throat size, porosity, penetration, root fusion
- Multiple imperfections found, **likely modes of failure**
 - Most welds on bracket 1 and 2 do not meet the minimum throat size, 3 mm
 - Root gaps of several welds exceed max limit of 0.6 mm for a 3 mm throat size
 - The larger the root gap, the smaller the area of fusion and the weaker the joint
 - Most welds exceed allowable porosity, 1.5%
 - Some welds have minimal weld penetration, only one critically inadequate weld
 - Clearance between bracket and pipe near weld that can weaken the joint
- Supplier quality issue; contacted suppliers to make changes in weld process

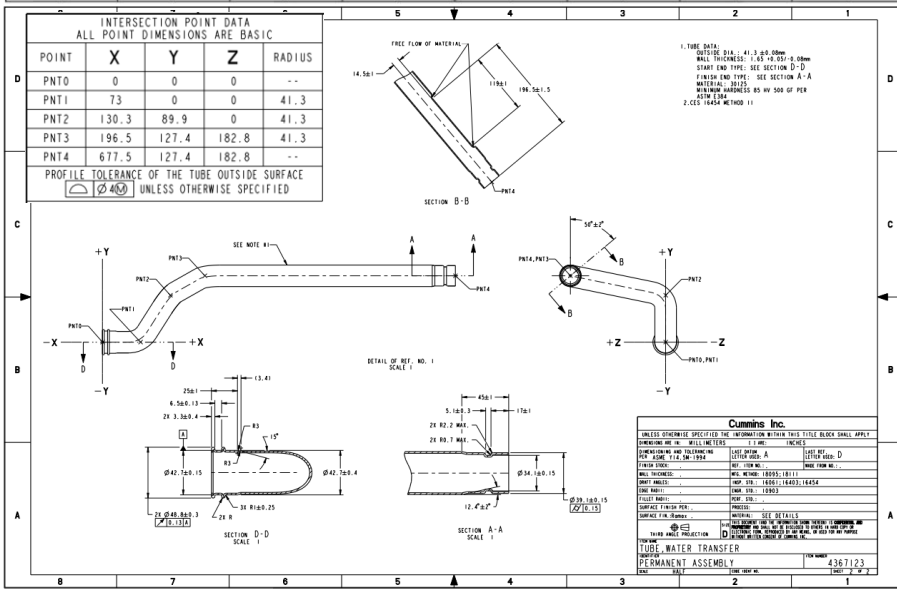
Dimensional Quality – Transfer Tube 4367122

- No dimensional variation greater than 0.5 mm between samples
- Some dimensions consistently deviate from print tolerance
- Failure due to excess static stress from:
 - Deviation at point 2 is **not** a failure mode
 - Point 2 position is not relevant to fit to the block
 - Deviation at point 4 x-direction is a **low-likelihood** failure mode
 - Point 4 position has a minimal effect on tube fit to the block
- Variation between parts is **not** a failure mode

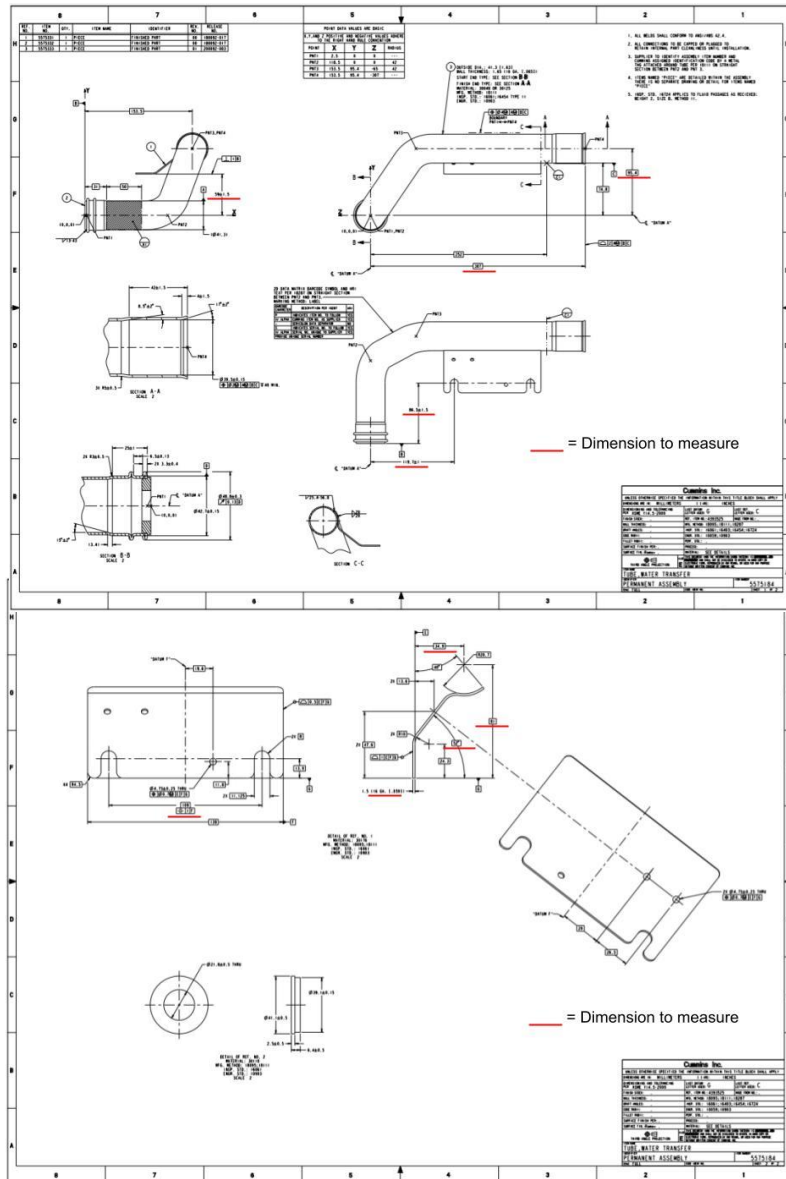
Dimensional Quality – Transfer Tube 5575183

- More dimensional variation than long tube, no greater than 3 mm
- Failed dimensions are not consistent, but many dimensions are out of tolerance
- Failure due to excess static stress from:
 - Deviation at point 4 is **low-likelihood**
 - Point 4 position has minor effect on fit
 - Incorrect bracket dimensions is a **low-likelihood** failure mode
 - Incorrect bracket position in any direction is a likely failure mode
 - Variation between parts is **low-likelihood**

- Dimensional quality issues
 - 5575183 bracket out-of-tolerance dimensions, inform supplier
 - If fit is an issue once dimensions are fixed, evaluate print dimensions
- Weld quality issues
 - 4367122 supplier has not yet responded to SQIE, follow up
 - Have supplier evaluate weld application process that may cause quality issues
- Static/dynamic stress
 - Validate durability of 1.5 mm long tube bracket thickness change
 - Cost justify with quote from supplier, create CTR -> CR to make this change

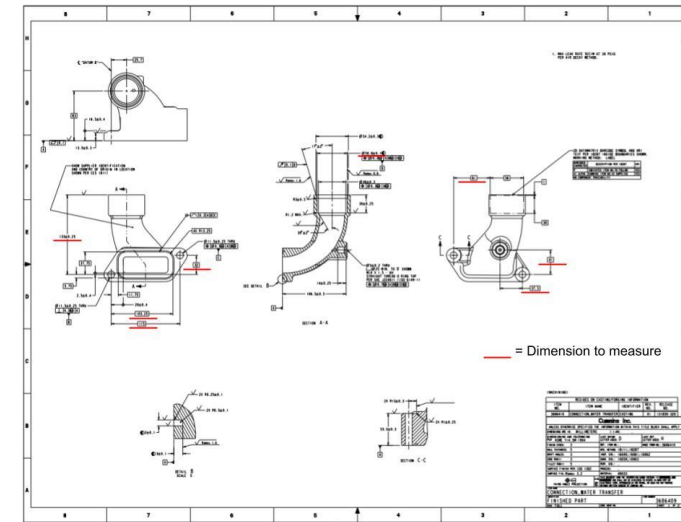
Dimensional Quality – Connector

- Dimensional issues commonly found in these connectors
- 4 samples chosen with visually-evident machining errors
- Measurement failures with an impact on pipe fit and internal stress
 - Datum C position deviates in the x direction
 - Distance from datum B to end of tube fit variation
 - These dimensions have an impact on the x-direction fit of the connector
 - Datum D position variation
 - This position affects the horizontal x-y location that the pipe fits to the connector
 - Distance from datum B to top of connector
 - If this dimension is too long, it may push pipe upward (z-direction)
- These dimensional errors found in the 3686409 connector **are** a likely cause of failure due to internal stress caused by imperfect fit

- Connector supplier: Mahabal Metals
- 3 hydraulic and 1 manual clamping mechanism in each CNC machine
- Manual clamping mechanism identified as cause of dimensional issues
- Replaced manual clamping mechanism with hydraulic clamping mechanism
- Should significantly reduce error in positioning from manual mechanism

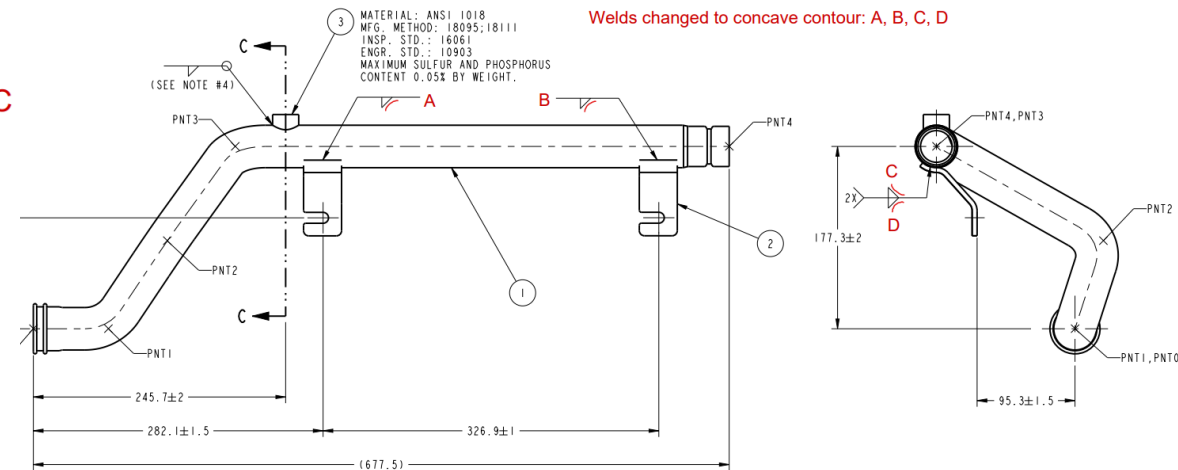
Welds changed to flat contour: A,B,C

- Weld geometry is currently unspecified on both transfer tube prints
 - Reflected by inconsistent welds seen on new and failed samples
- Add weld geometry specifications to each tube based on ANSYS analysis
 - Determined the best weld geometry to reduce stress concentration (slide #_)
 - Short tube weld contour: Flat weld
 - Long tube weld contour: Concave weld

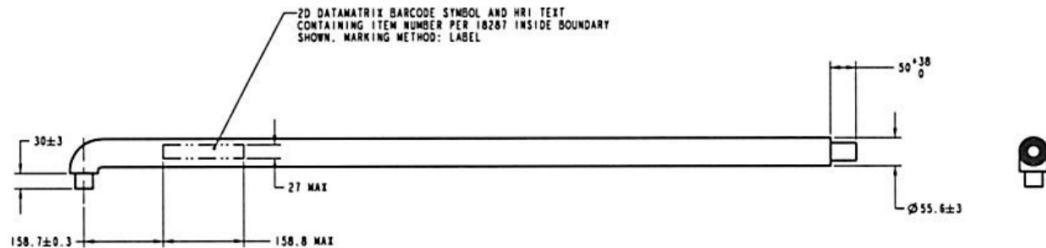
- Odin breather hose (5348266) is difficult to install due to size and fit
- Insulation covers full length of hose and makes contact with the shutoff valve
- May create long-term wear on insulation and shutoff valve during operation

- Remove a section of insulation from top part of breather hose
 - Identify point of interference / contact and determine insulation removal needed
- Engine heat is sufficient to prevent top section of breather hose from freezing without insulation
 - Insulation at the top of the breather hose is due to supplier design
 - Automotive hose (3688597) previously used in the Odin engine has a significant top portion with no insulation and no freezing issue claims
- Current insulated Odin hose (5348266) was implemented due to better fit as a longer hose than the automotive model
 - We cannot re-implement the automotive model, must modify existing hose
- The fit of insulation to the tube has no clearance, will remain secure if any insulation is removed

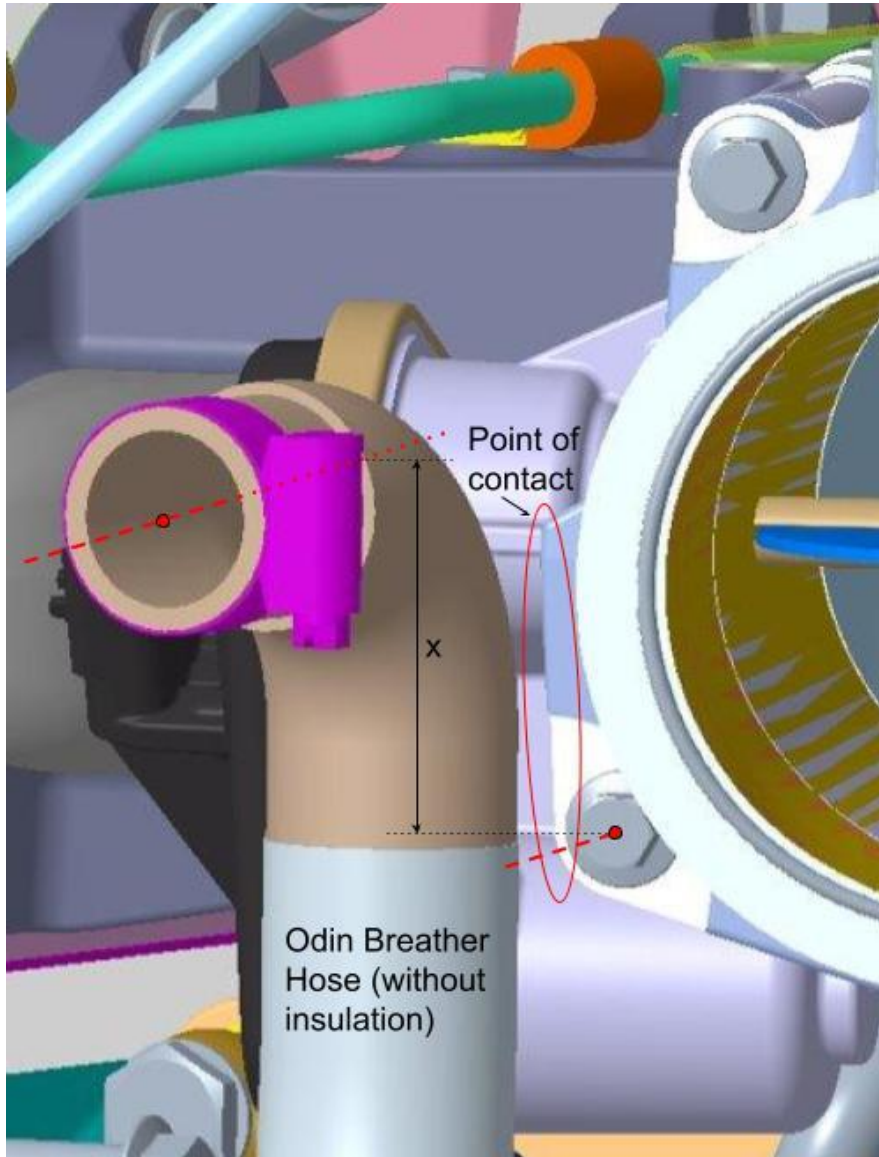
- Distance from top of hose centerline to lowest possible insulation contact point $x = 47.7$ mm
- Insulating tube from the top of the hose must be removed so that there is no insulation above 47.7 mm from this centerline
- To allow for plenty of clearance, remove at least **75 mm** of insulation from top hose centerline
