JTC Engineering Investigation

Water Transfer Tubes Crack along Welded Joints, Causing a Leak

Investigation Leader: Jessica Nicholson

Date Opened: 6/21/2021

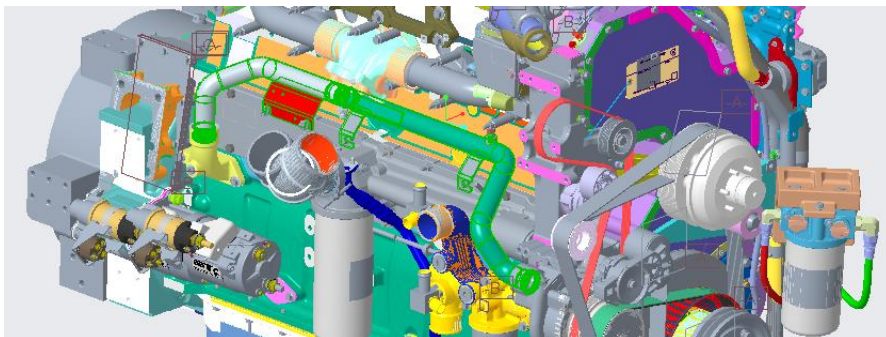
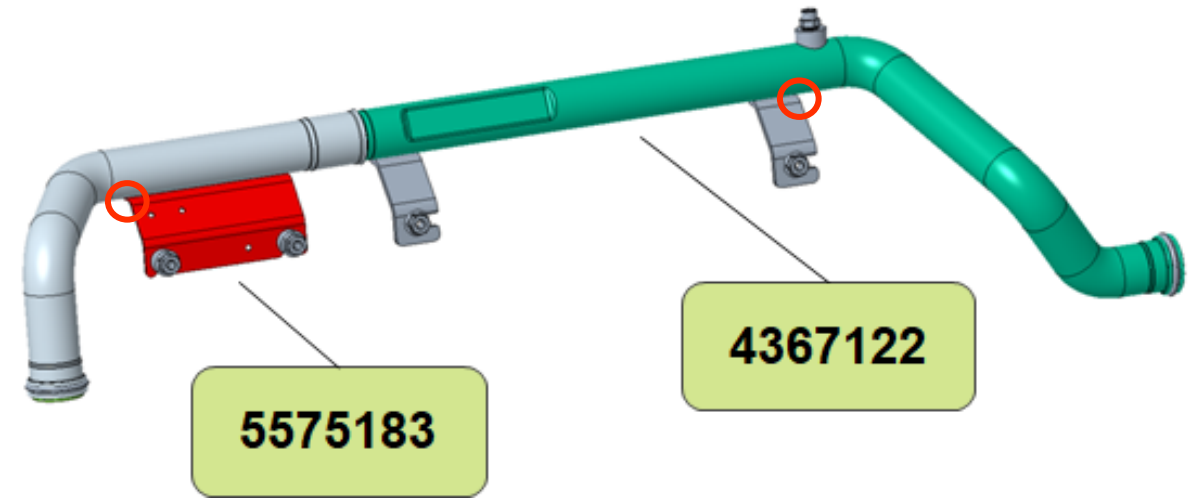
- Two water transfer tubes
 - Fails along circled weld joints
- Configurations:
 - 11BX03 – Rottweiler e5
 - 18BX03 – Pit Bull e6
 - 17MX03 – X15 Marine
 - 20CX03 – Tier 2 Industrial
 - 21GX03 – Genset

Water transfer tube in the Rottweiler, obstructive parts hidden

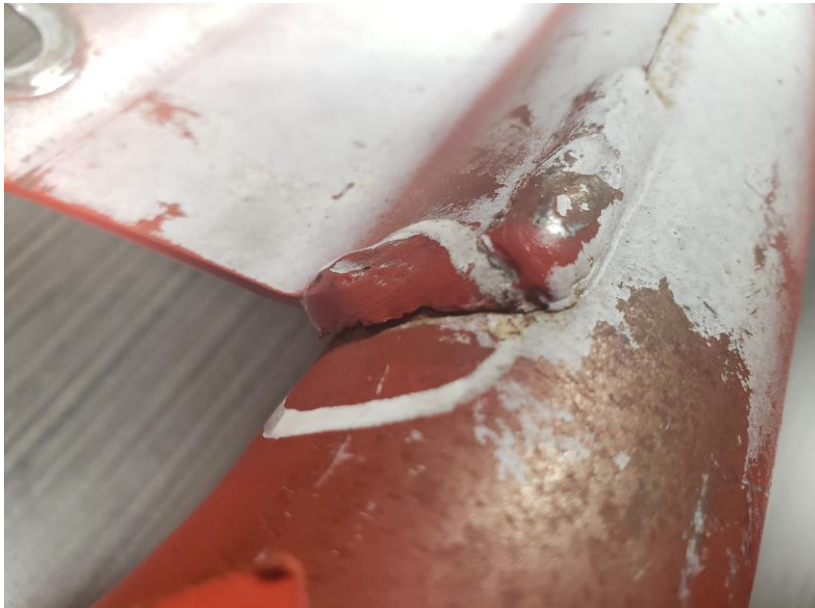
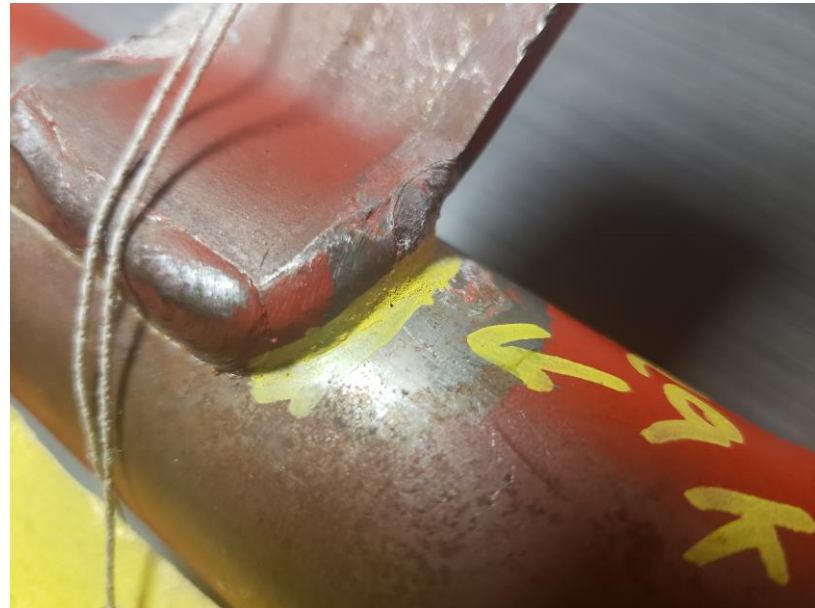
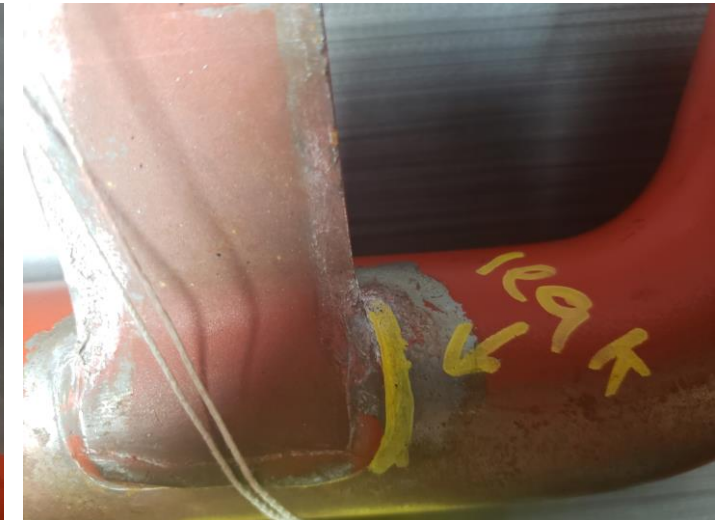
Failure Description

- Fail Code: KCTA
- Both parts crack along weld joint connecting bracket to tube
- Crack can get worse and lead to failure if not identified and fixed
- Leaks are commonly reported along this crack

- Failure mode is most likely a form of excessive stress or low material strength due to quality issues
- Create additional welds behind each bracket to secure to the pipe
- This temporary solution will create a stronger joint to resist failure due to stress or low strength while I investigate the cause of the weld cracking

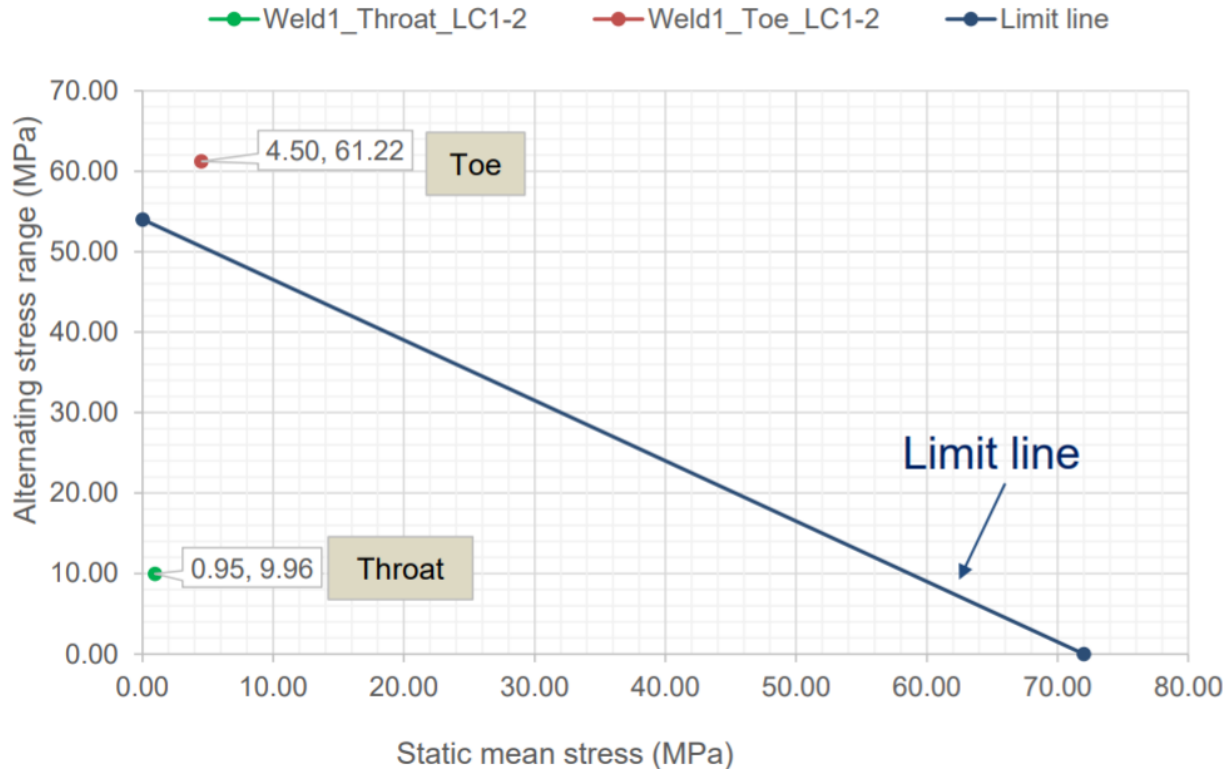
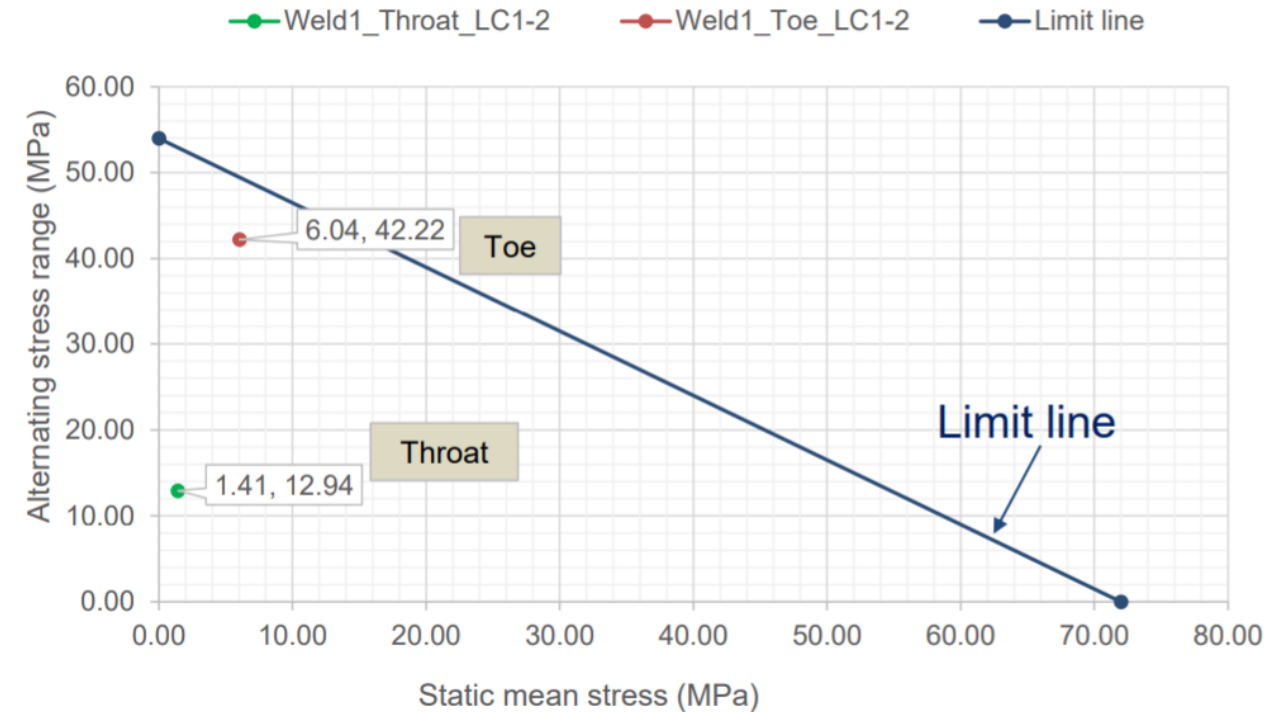
Current design

- Supplier conducted a comparative ANSYS analysis on current welded joint vs joint with additional weld
 - Evaluates the impact of the additional weld on stress within the system
- Found average stress acting upon weld toe and throat of each welded joint
 - Given same applied force of 10G on each system for alternating stress
 - Hot spot method used to find mean stress
- Generated Goodman diagrams with mean and alternating stress limits
 - Compares level of stress acting upon joints of current design vs additional weld
 - Determines how likely each design is to experience fatigue stress at given force
- Joints with the additional weld experience **significantly less stress** and are less likely to fail due to fatigue stress

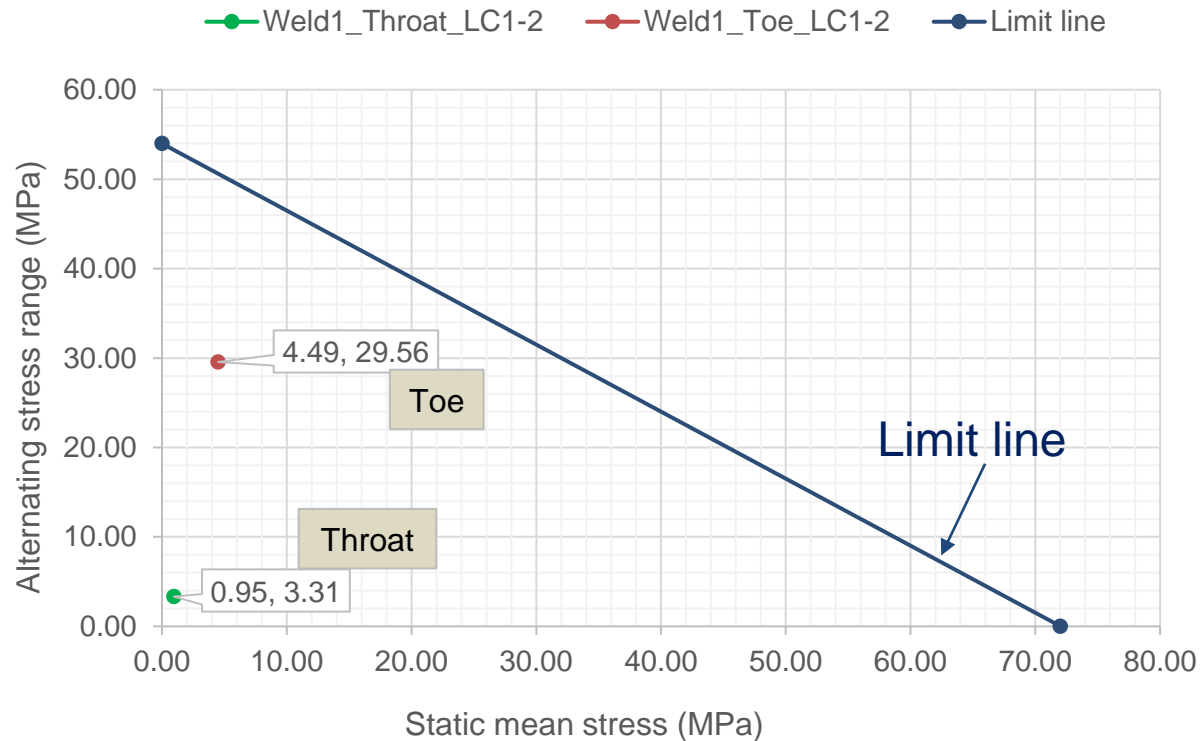
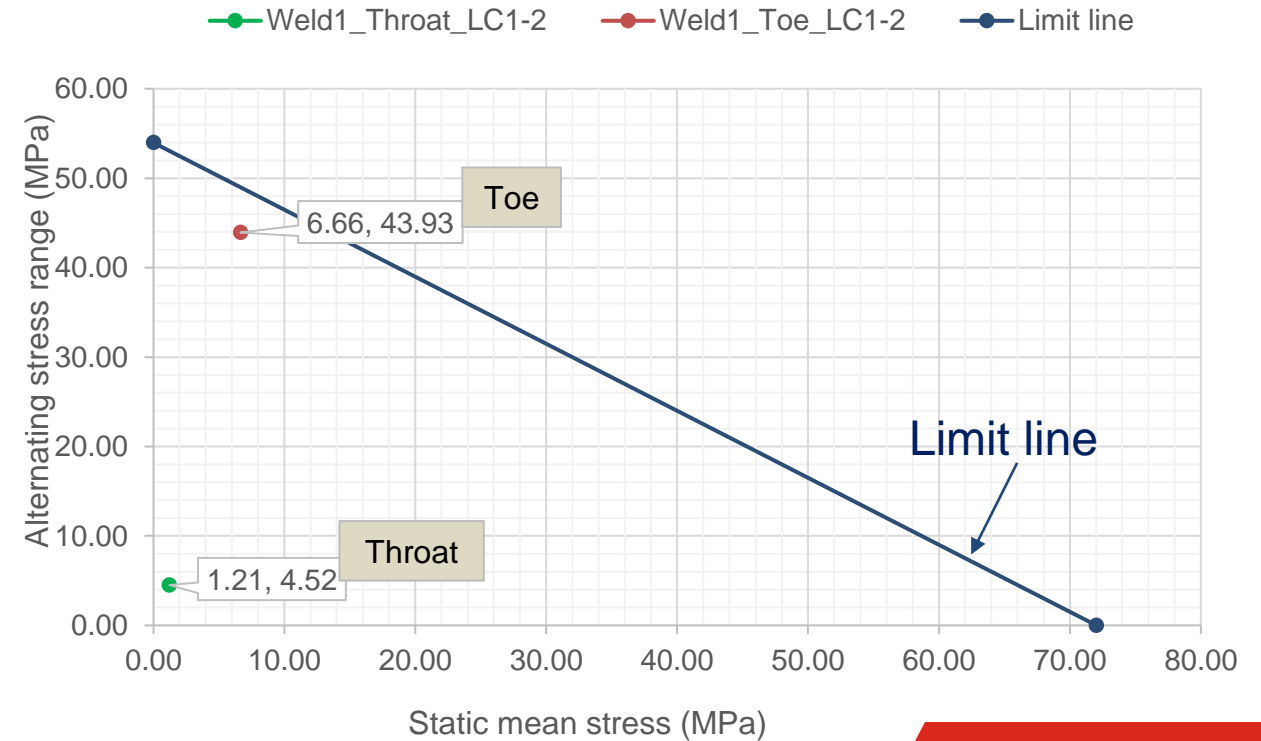
With step 3 additional weld implemented:

- Long tube (4367122)
 - Weld location 1 toe
 - Alternating stress reduction: 51.7%
 - Mean stress reduction: 0.22%
 - Weld location 2 toe
 - Alternating stress increase: 4.05%
 - Mean stress increase: 10.3%
 - Avg alternating stress effective reduction rate = 23.8%
 - Avg mean stress effective increase rate = 5.04%
 - Solution effective rate = 21.1%
- Short tube (5575183)
 - Weld location 1 toe
 - Alternating stress reduction: 65.5%
 - Mean stress reduction: 80.5%
 - Weld location 2 toe
 - Alternating stress increase: 1.00%
 - Mean stress reduction: 43.2%
 - Avg alternating stress effective reduction rate = 32.3%
 - Avg mean stress effective reduction rate = 61.9%
 - Solution effective rate = 38.9%

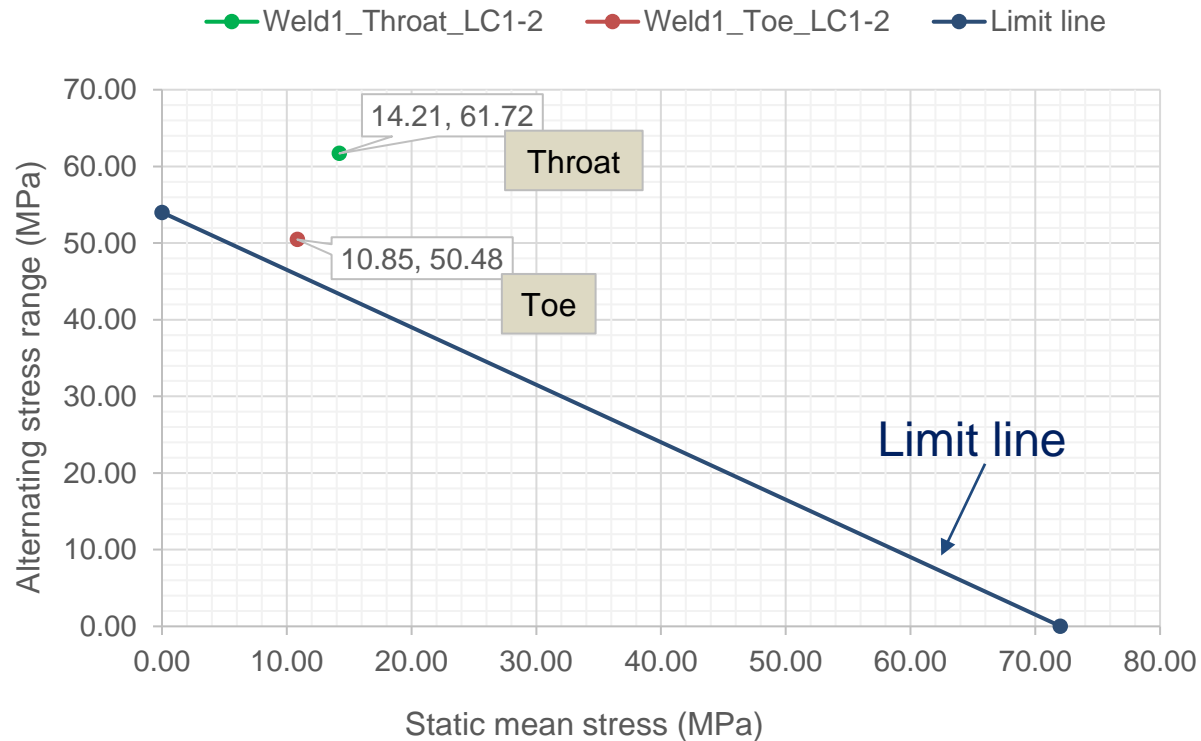
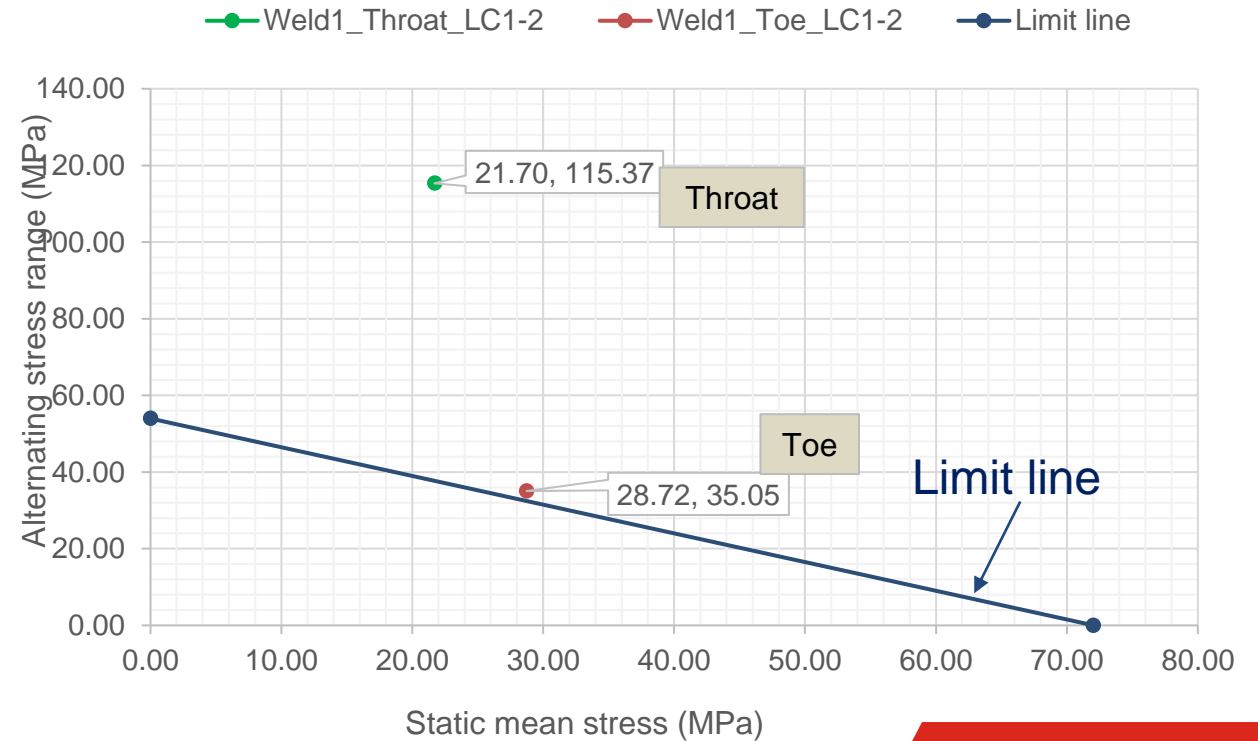
Current design:

- Conducted same comparative ANSYS analysis as long tube analysis on current welded joint vs additional weld
 - Evaluates the impact of the additional weld on stress within the system
- Found average stress acting upon weld toe and throat of each joint
 - Same applied force of 10G on each system for alternating stress
 - Hot spot method used to find mean stress
- Generated Goodman diagram with lowest stress limits
 - Compares level of stress acting upon joints of current design vs additional weld
 - Determines how likely each design is to experience fatigue stress
- Joints with the additional slotted weld experience **significantly less stress** and are less likely to fail due to fatigue stress

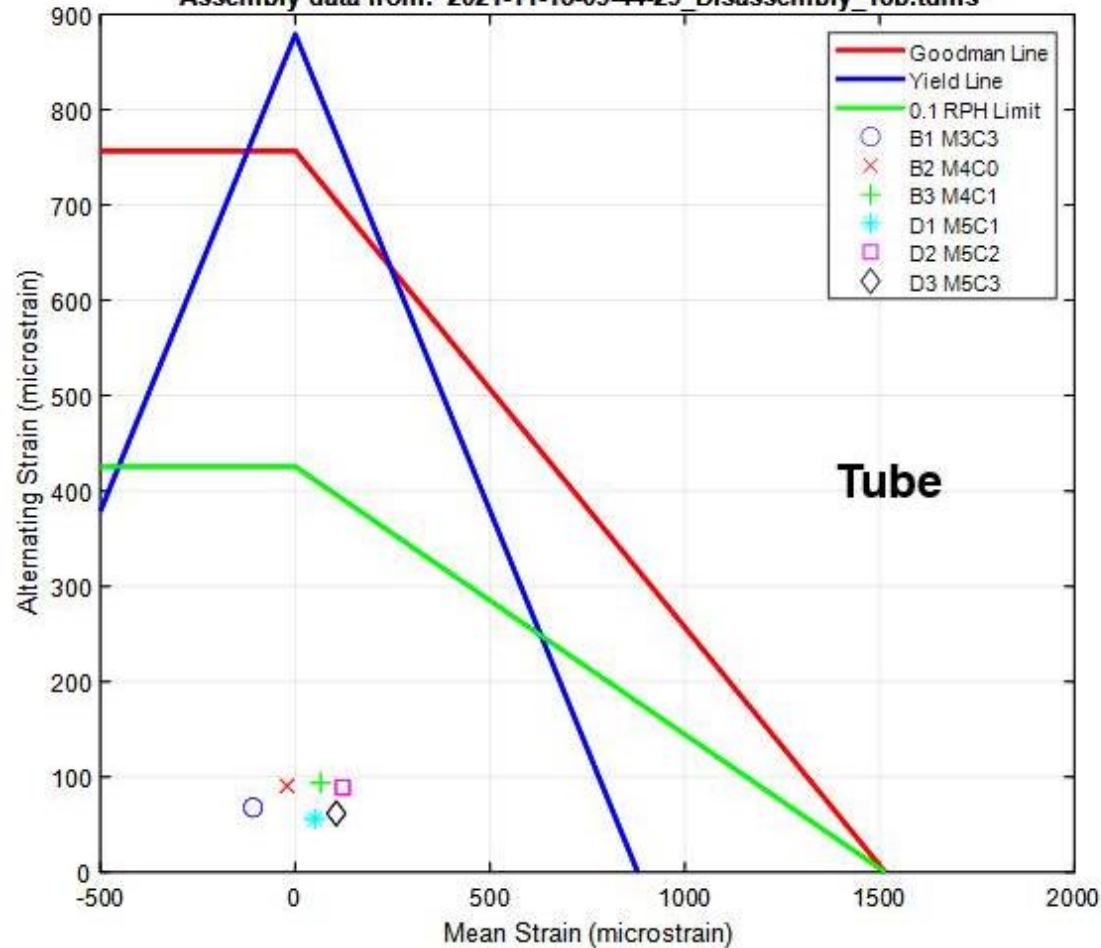
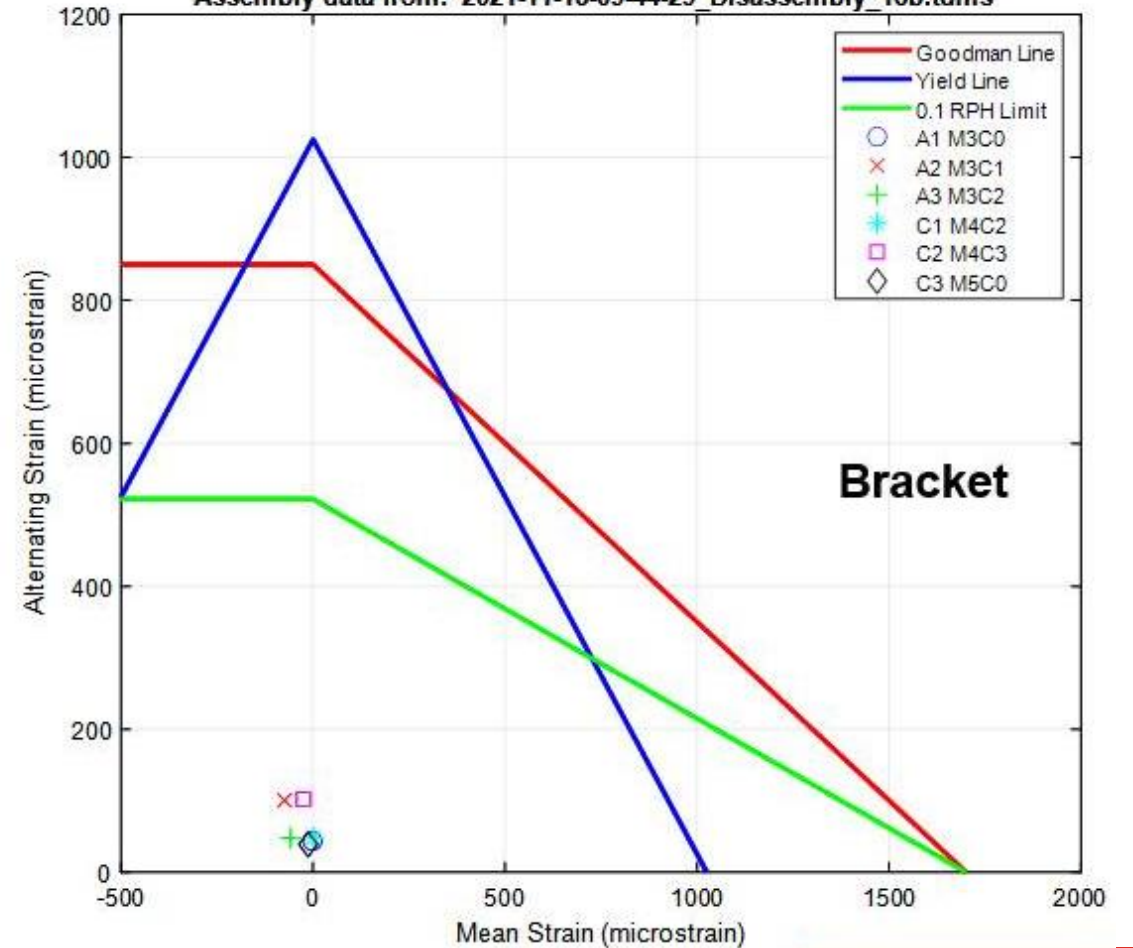
4367122 Goodman Diagrams

- Mean, alternating, and assembly stress on the welded joint are all minimal
- Stress may rise in uncommon circumstances, high RPH and 7th mode, but still does not exceed Goodman line
- Dimensional disparities may cause higher assembly stress and impact alternating stress
- Therefore, high static or dynamic stress are **unlikely** failure modes for dimensionally in-spec transfer tubes

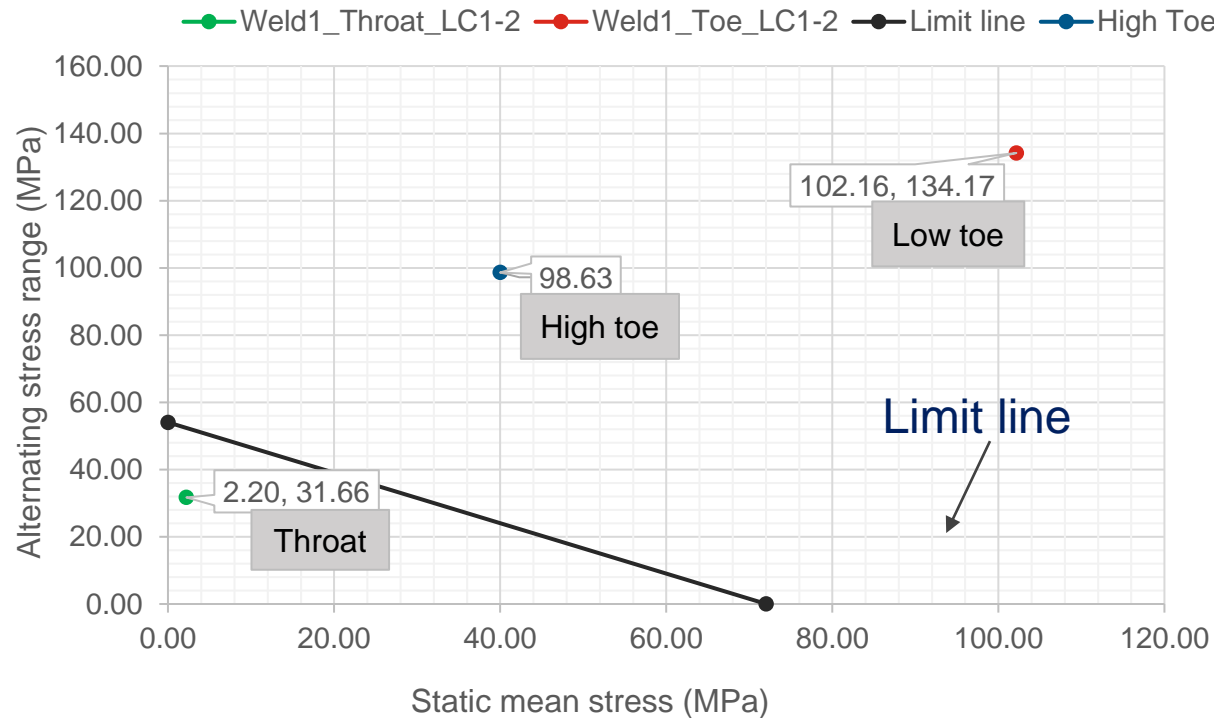
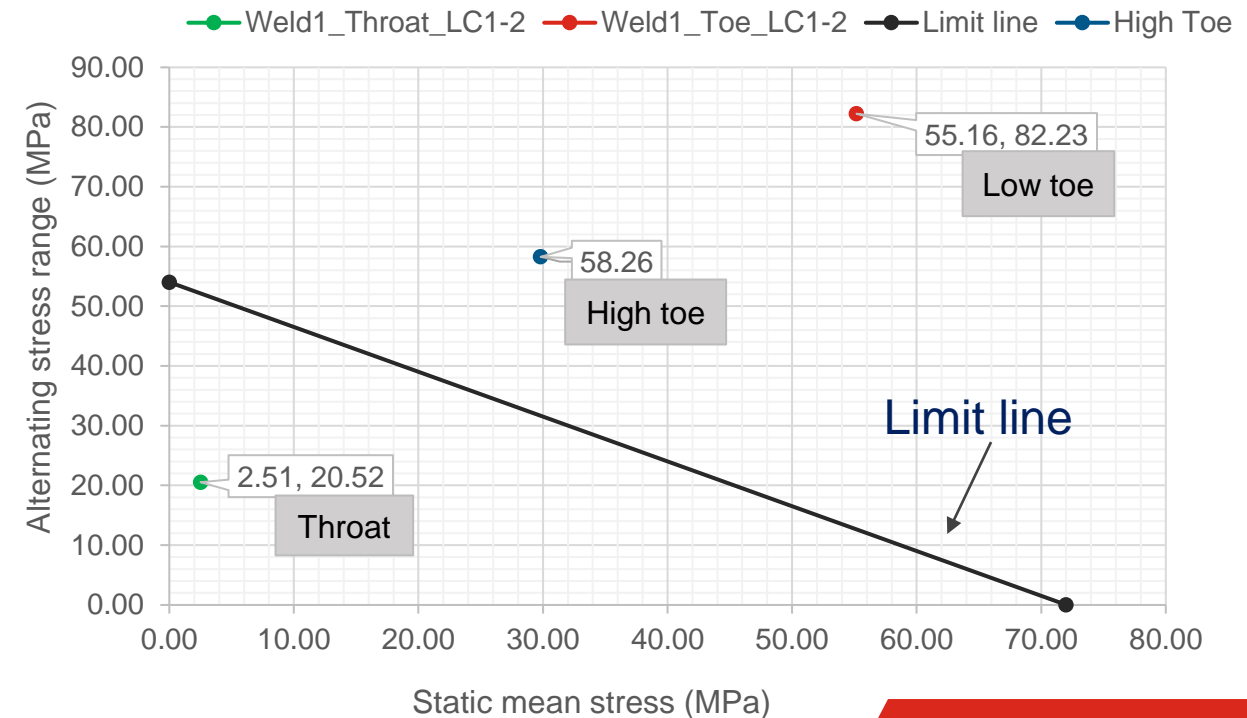
Long tube convex weld:

- Weld geometry in new and failed samples is inconsistent
- ANSYS results do not align with theoretical stress concentration geometry
- Best weld concentration per tube and weld location
 - Short tube pipe connection and bracket connection: Flat weld
 - Long tube pipe connection and bracket connection: Concave weld
- These geometries are ideal as they have the lowest stress concentration
 - Ensure weld does not penetrate through the pipe for the short tube, creates concave geometry
 - Meet weld throat size requirement for the long tube, but do not exceed as to create convex geometry with a high-angle weld toe
- Excess stress concentration is a **likely failure mode** for
 - Failed short tubes with a convex or concave weld geometry
 - Failed long tubes with a flat weld geometry

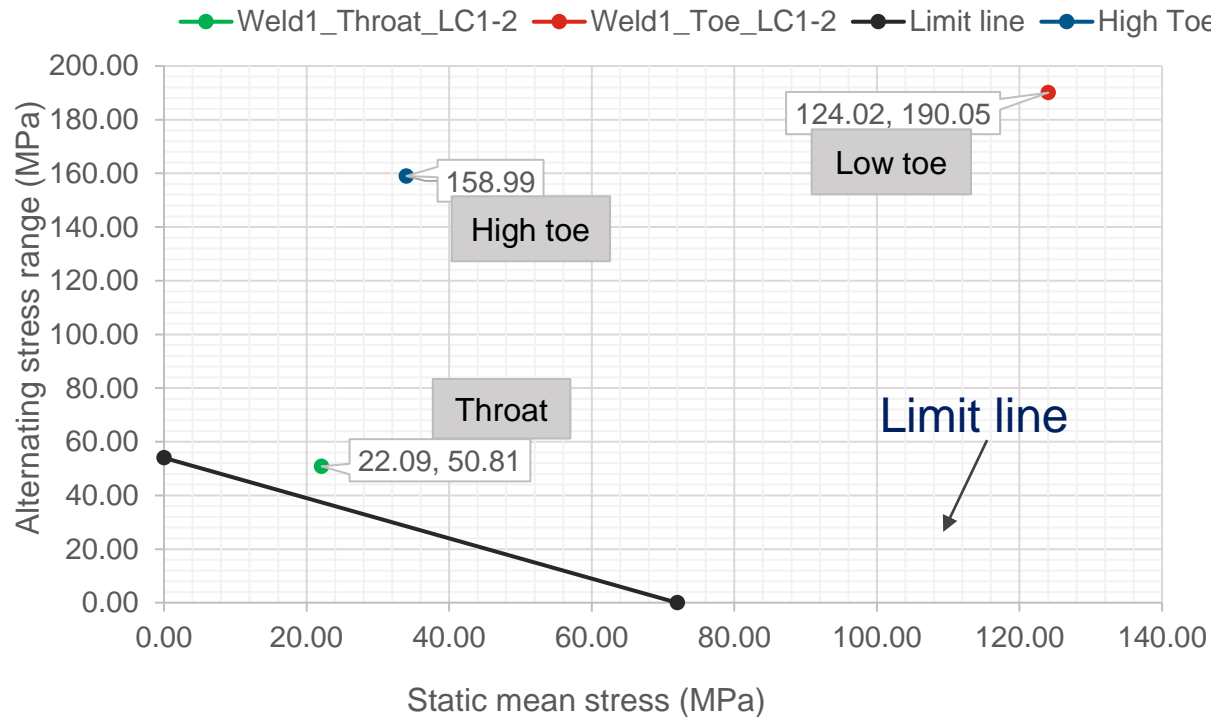
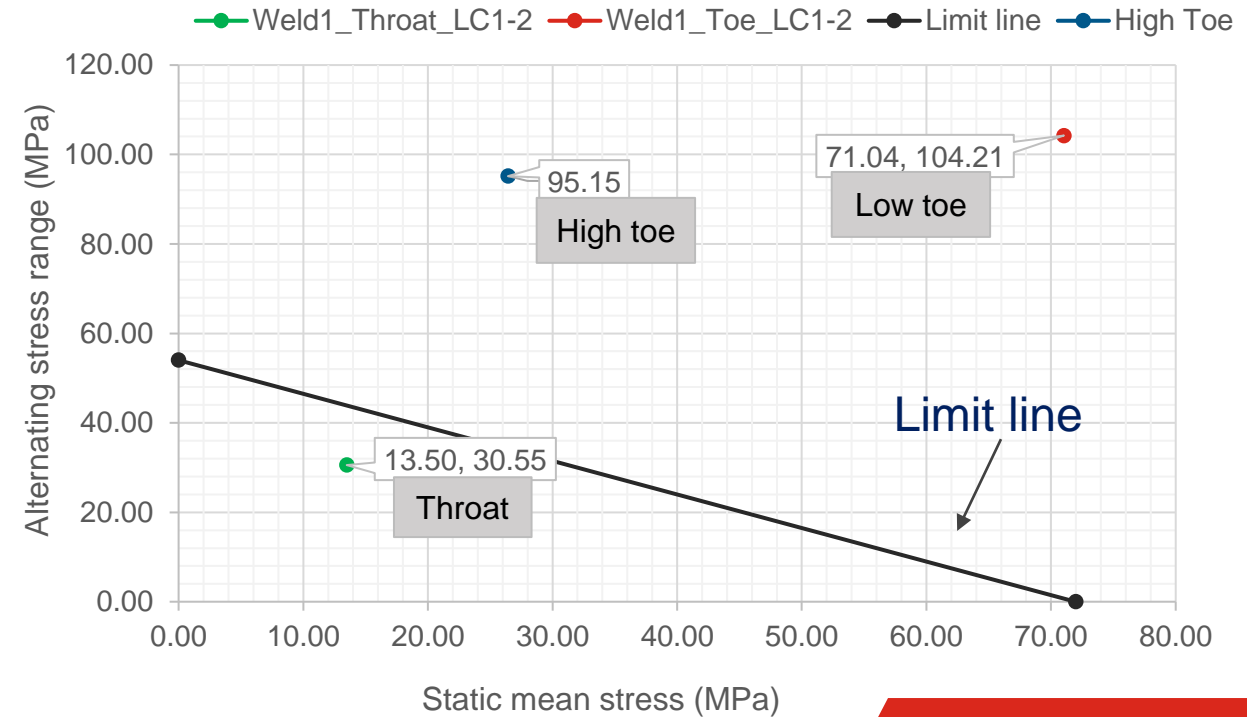
Weld Location 2

High Stress Concentration

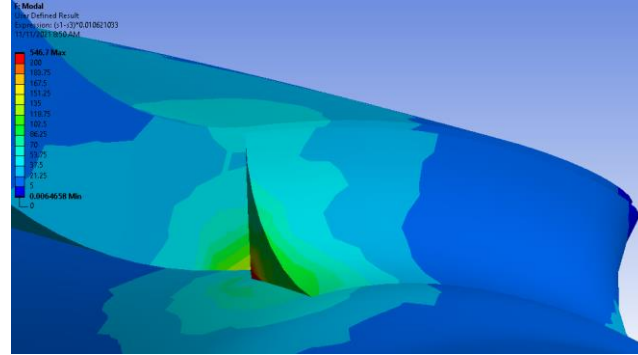
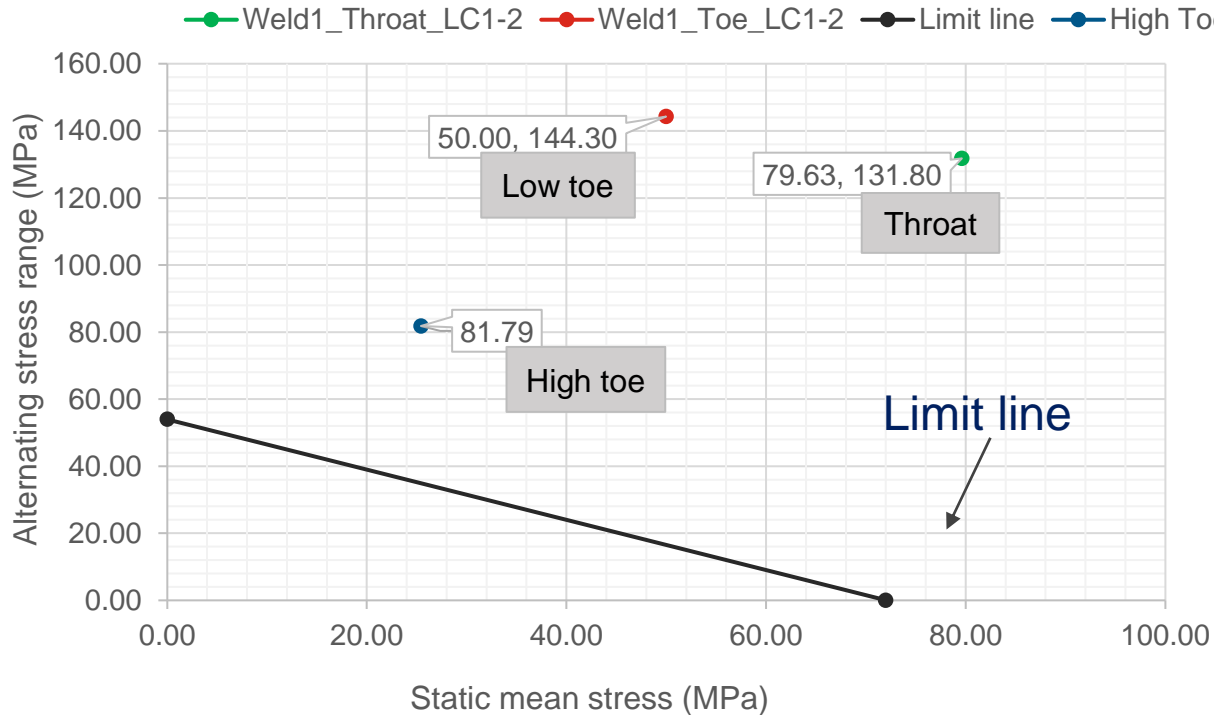
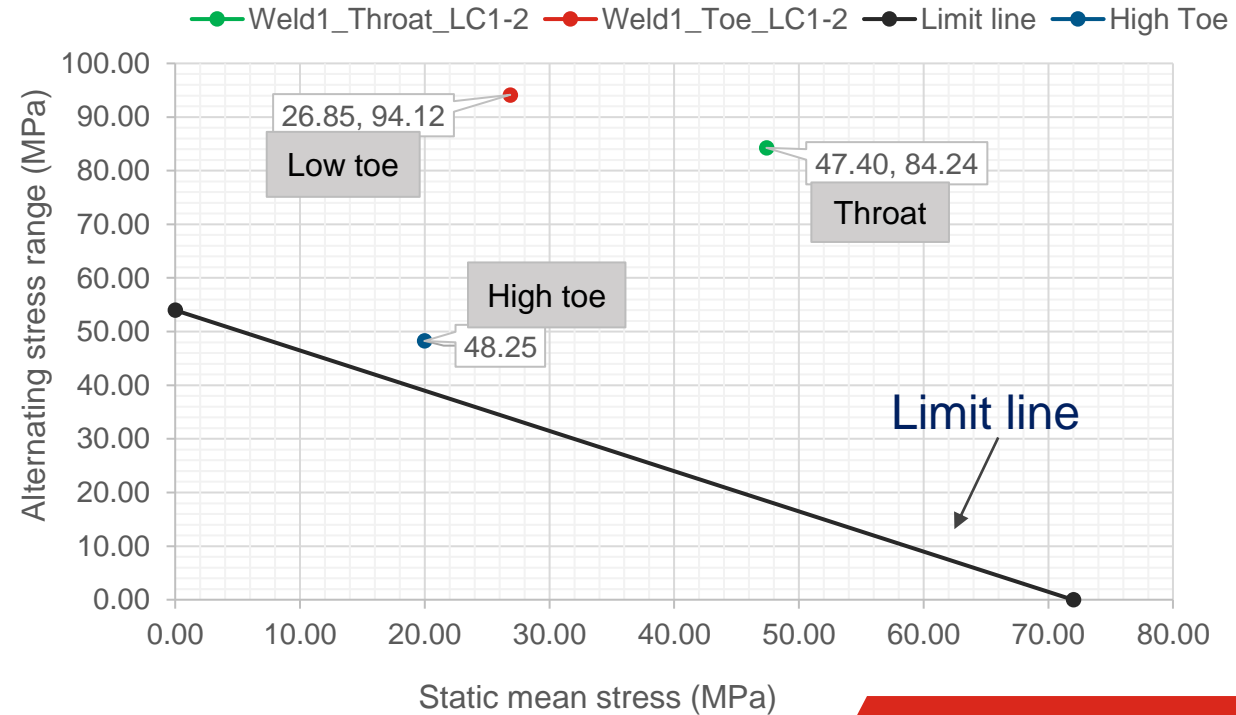
Long tube concave weld:

High Stress Concentration

- Weld geometry is currently unspecified on both transfer tube prints
 - Reflected by inconsistent welds seen on new and failed samples
- Add weld geometry specifications to each tube based on ANSYS analysis
 - Determined the best weld geometry to reduce stress concentration (slide #_)
 - Short tube weld contour: Flat weld
 - Long tube weld contour: Concave weld

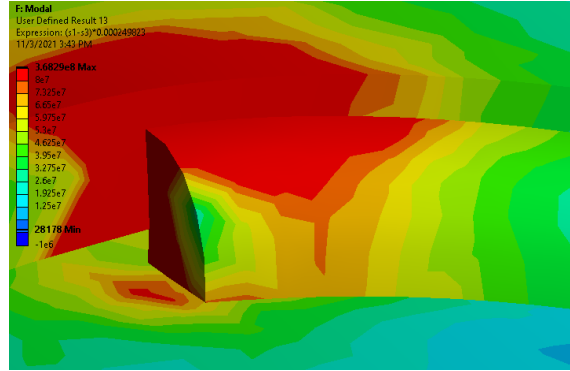
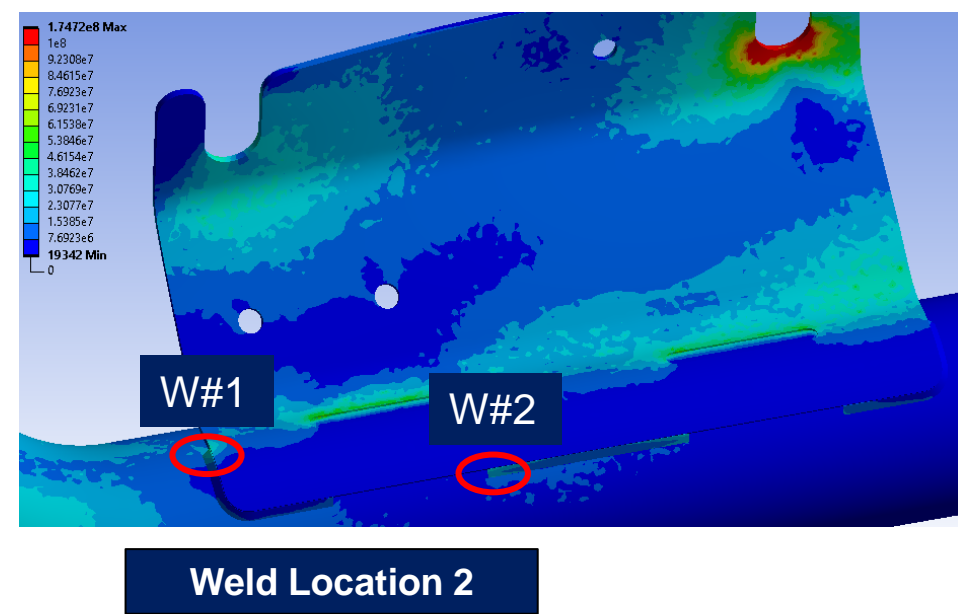
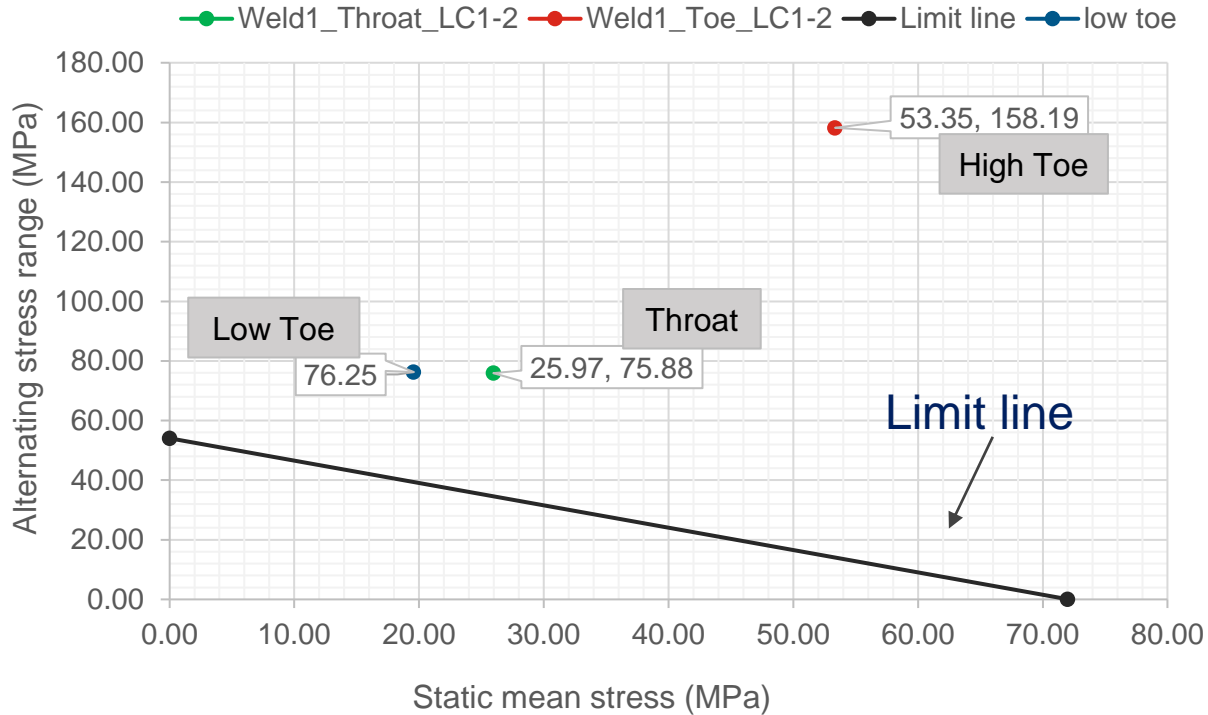
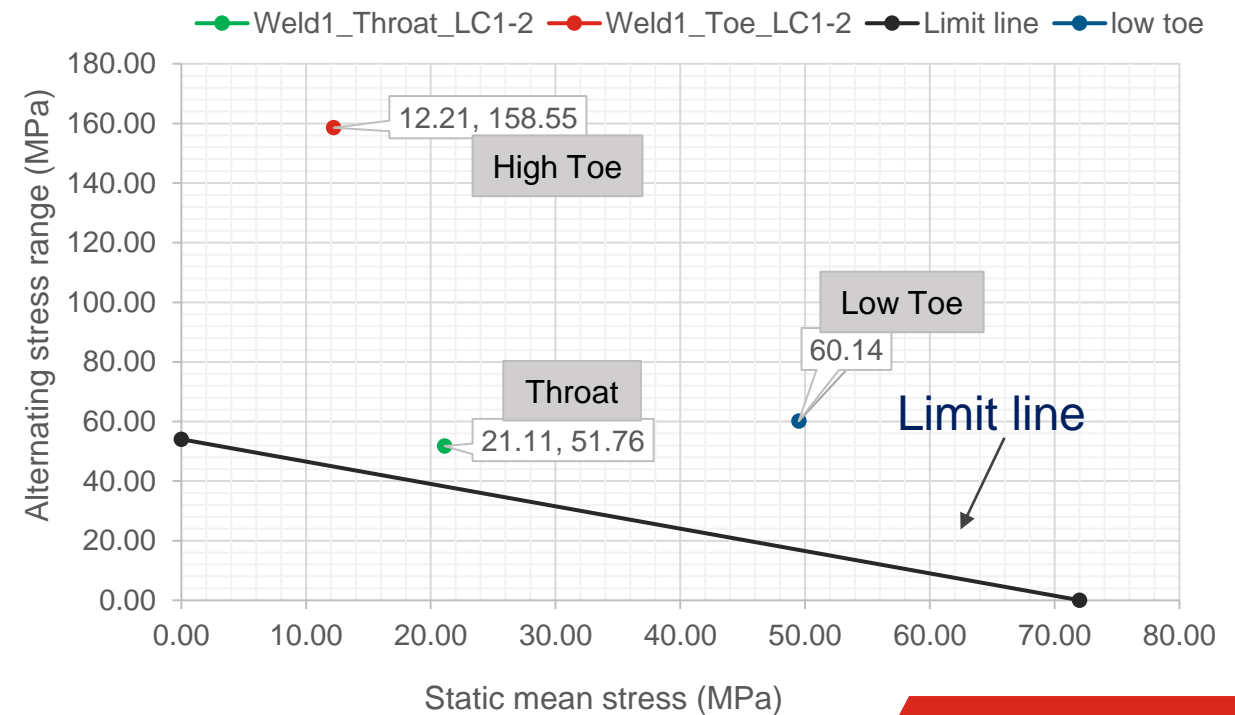
Short tube convex weld:

High Stress Concentration

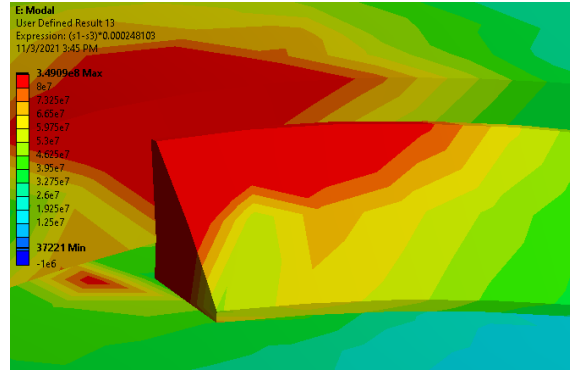
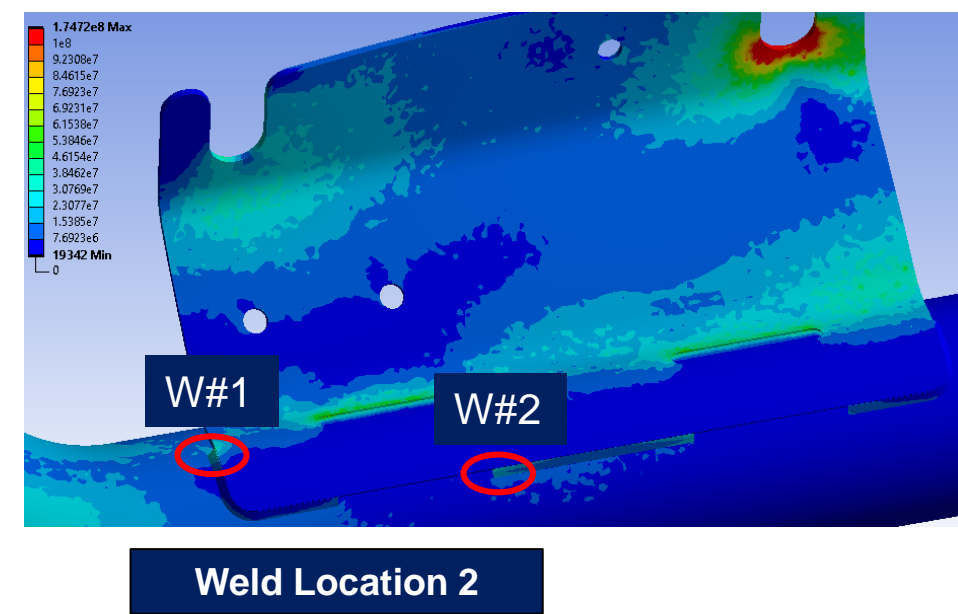
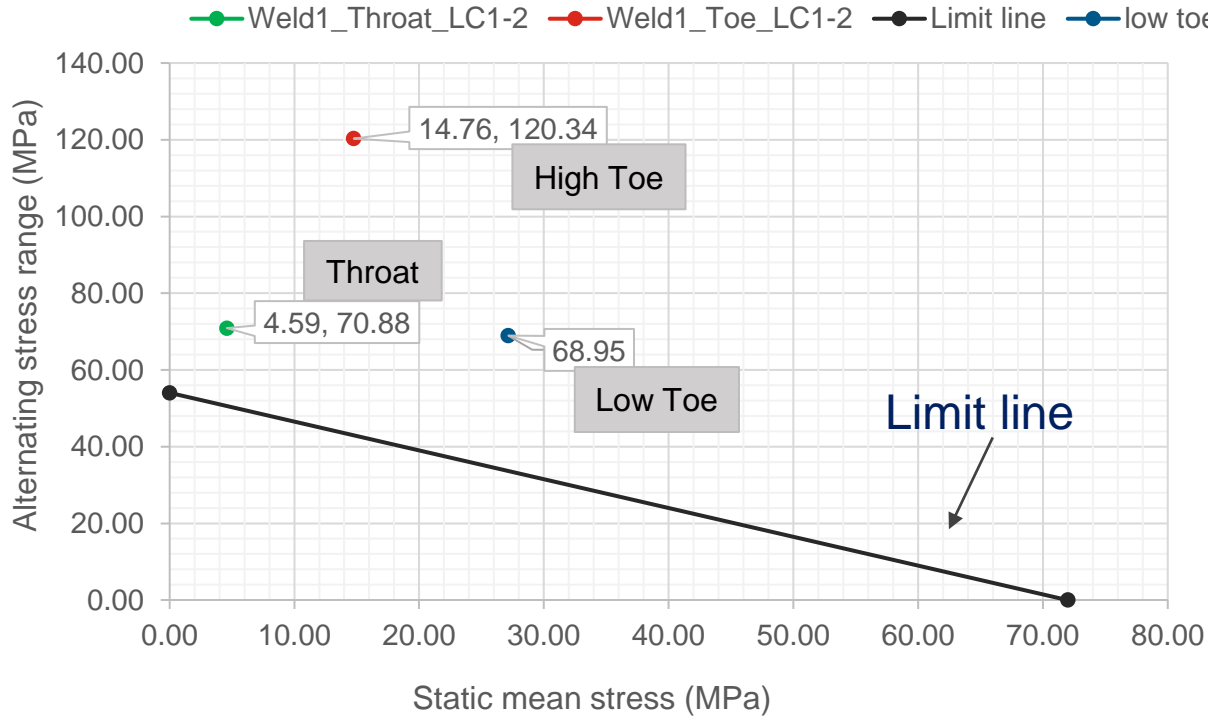
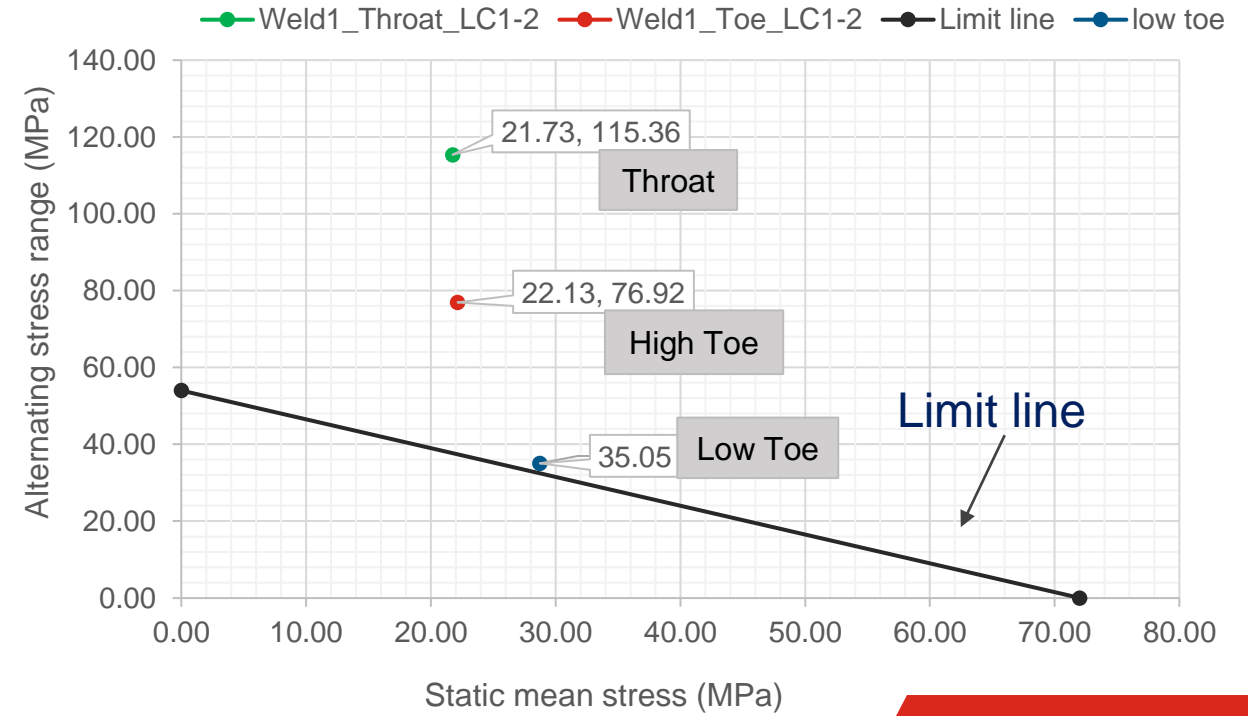
Short tube flat weld:

High Stress Concentration
