JTC Engineering Investigation

Water Transfer Tubes Crack along Welded Joints, Causing a Leak

Investigation Leader: Jessica Nicholson

Date Opened: 6/21/2021

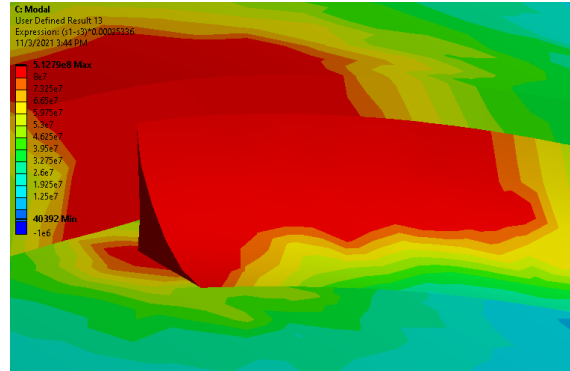
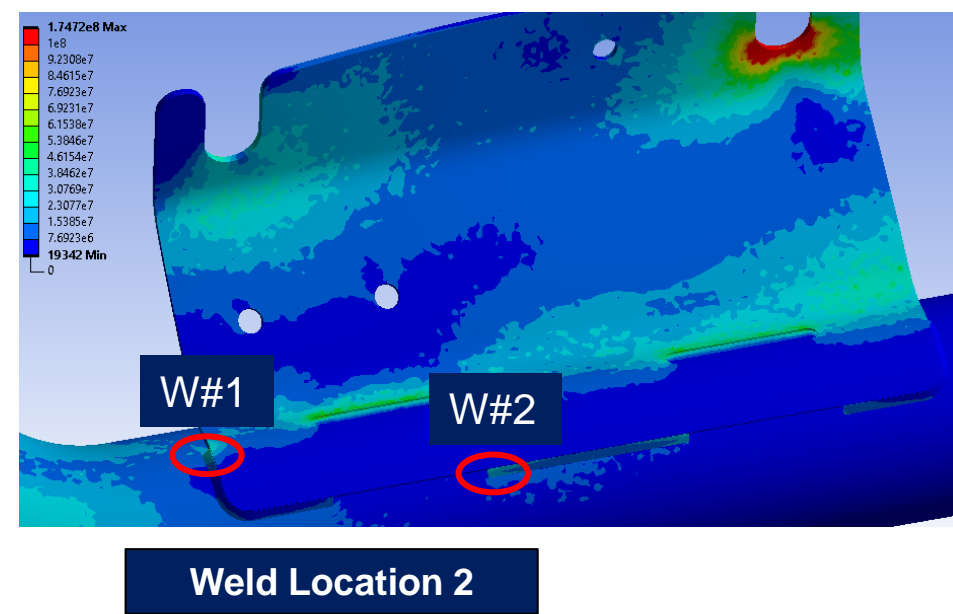
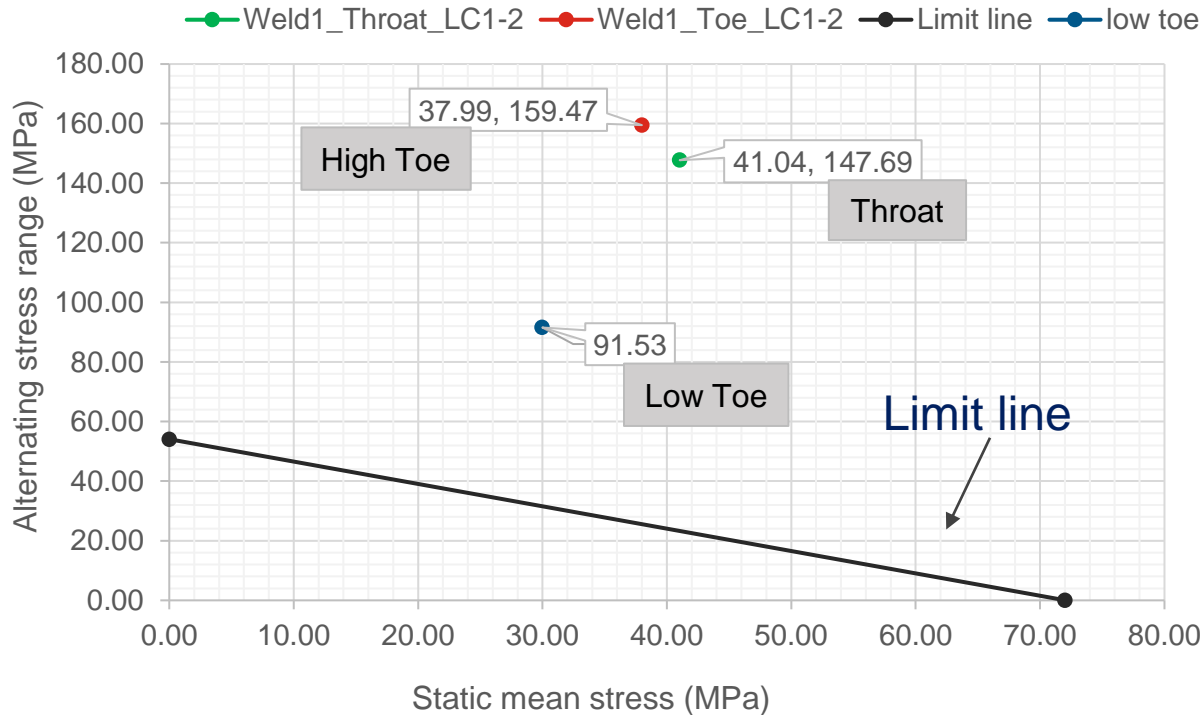
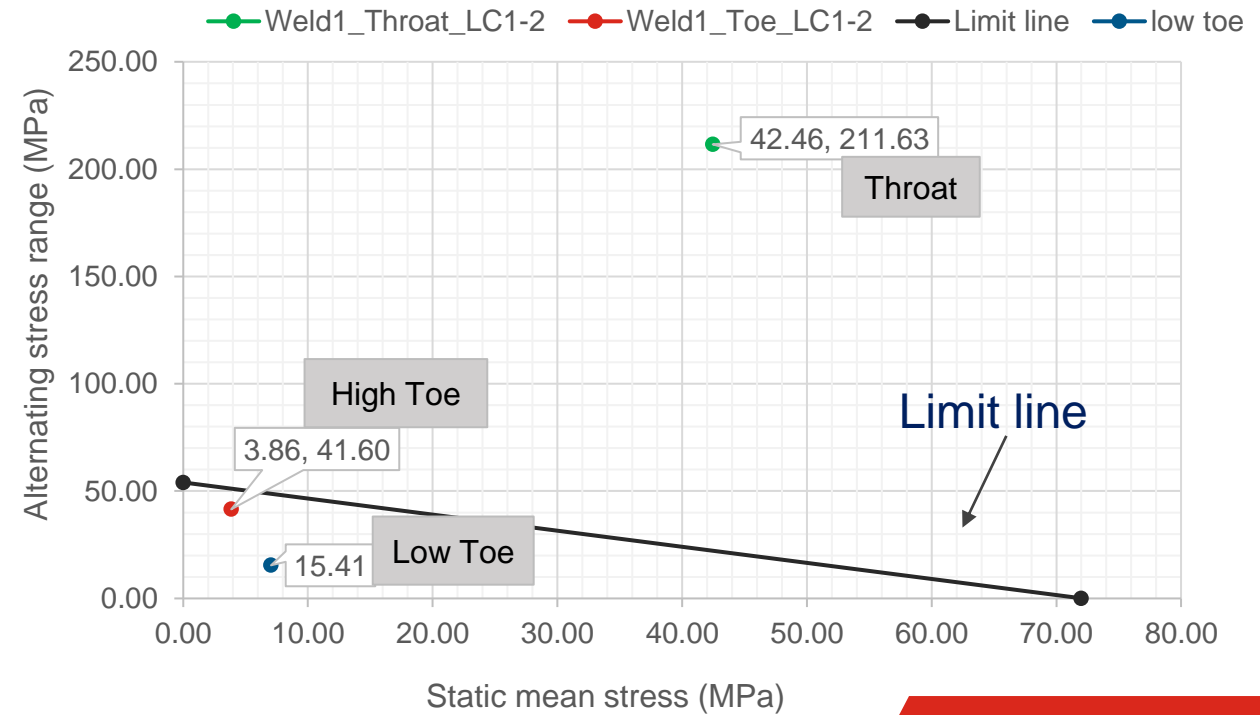
Short tube concave weld:

- Weld geometry in new and failed samples is inconsistent
- ANSYS results do not align with theoretical stress concentration geometry
- Best weld concentration per tube and weld location
 - Short tube pipe connection and bracket connection: Flat weld
 - Long tube pipe connection and bracket connection: Concave weld
- These geometries are ideal as they have the lowest stress concentration
 - Ensure weld does not penetrate through the pipe for the short tube, creates concave geometry
 - Meet weld throat size requirement for the long tube, but do not exceed as to create convex geometry with a high-angle weld toe
- Excess stress concentration is a **likely failure mode** for
 - Failed short tubes with a convex or concave weld geometry
 - Failed long tubes with a flat weld geometry

- Weld geometry is currently unspecified on both transfer tube prints
 - Reflected by inconsistent welds seen on new and failed samples
- Add weld geometry specifications to each tube based on ANSYS analysis
 - Determined the best weld geometry to reduce stress concentration (slide #_)
 - Short tube weld contour: Flat weld
 - Long tube weld contour: Concave weld

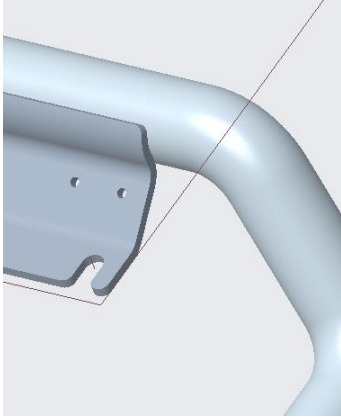
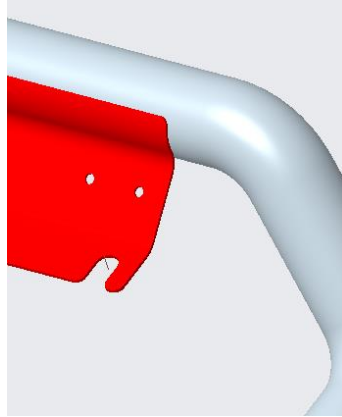
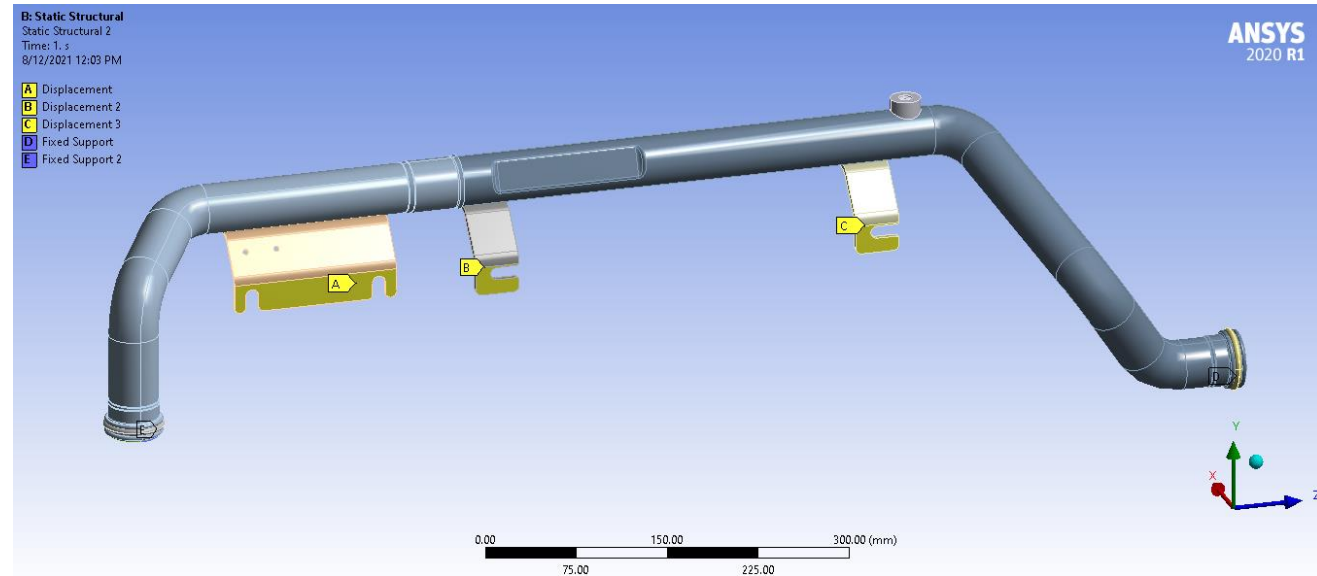
- Two ANSYS simulations performed
 - Given displacement perpendicular to each bracket face = 1 mm
 - Same fixed support points at both ends of transfer tubes
 - Both full-system simulations measure equivalent stress
- Each simulation is run with a different bracket thickness, 1.5 and 4.8 mm
- Locations of interest – each welded bracket-to-pipe joint
 - Stress measured at these locations; stress distribution shown
 - Stress distribution compared between simulations

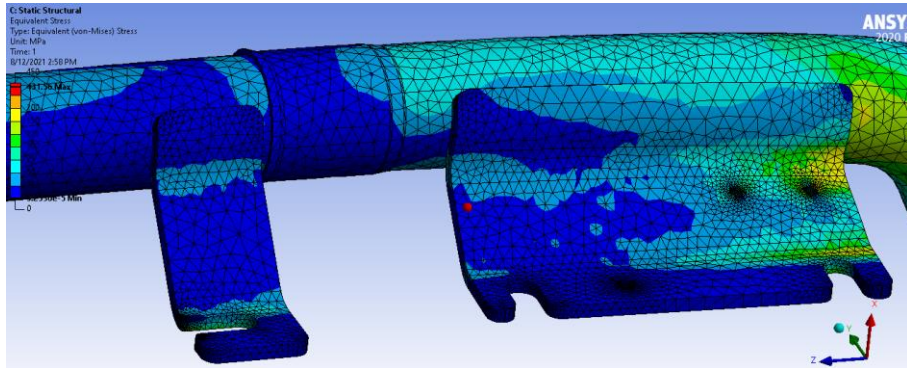
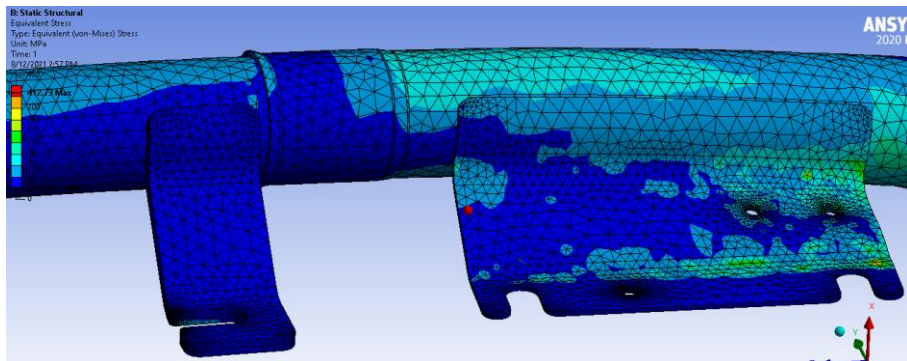
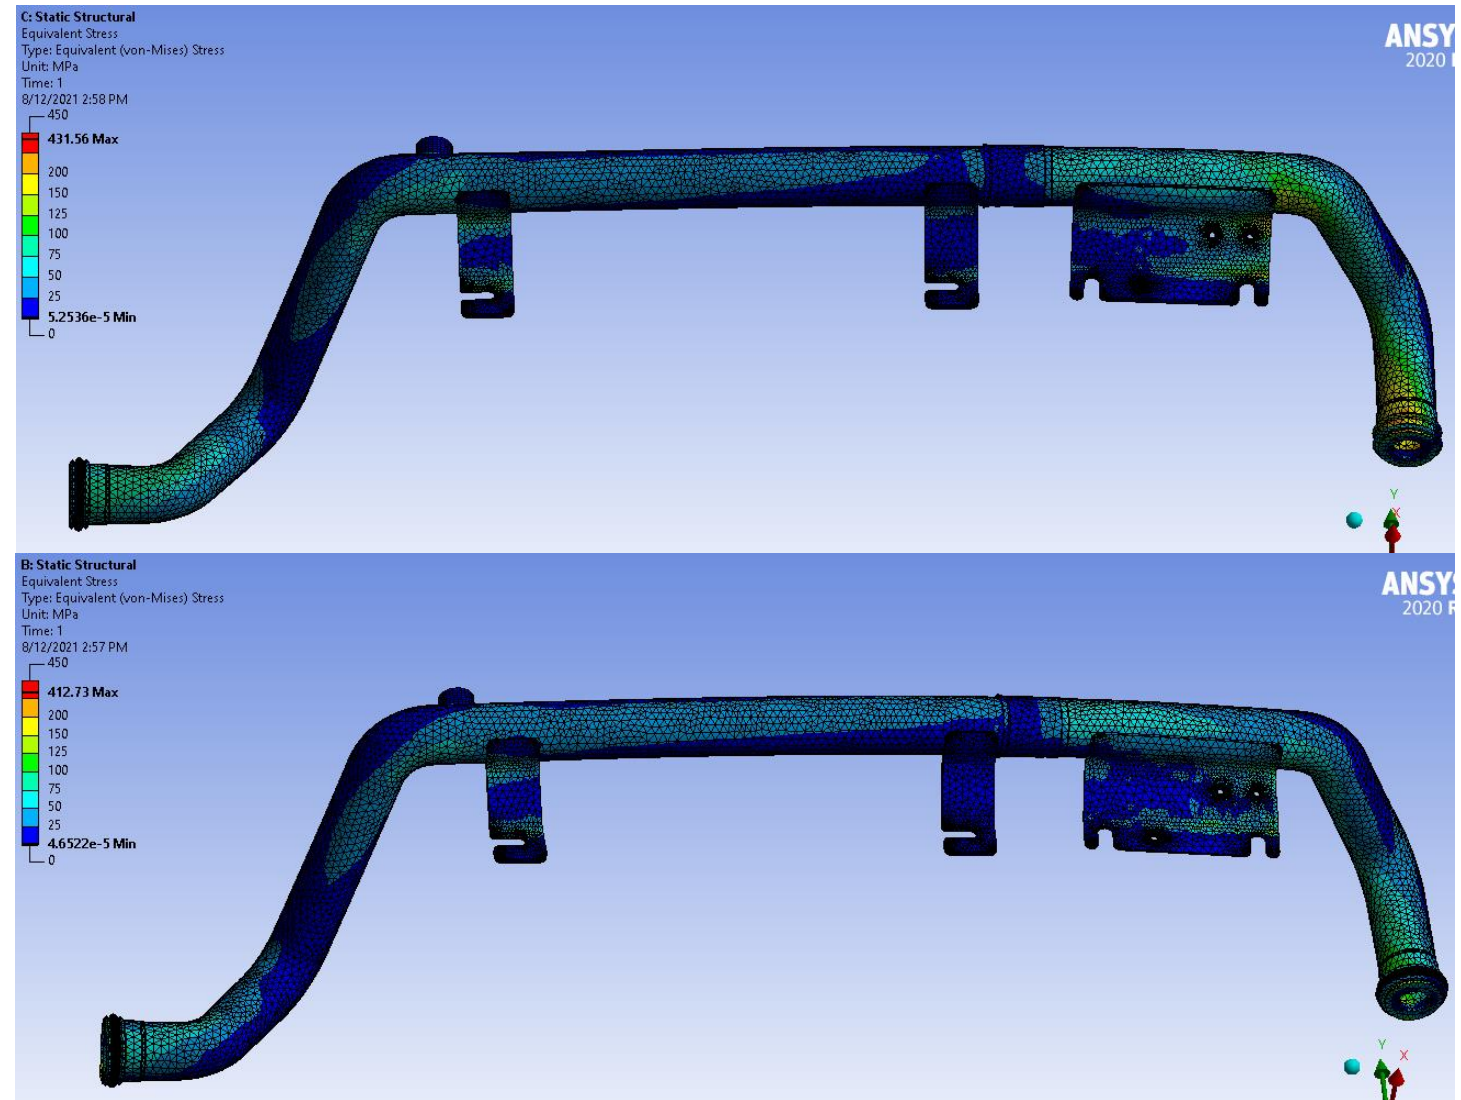
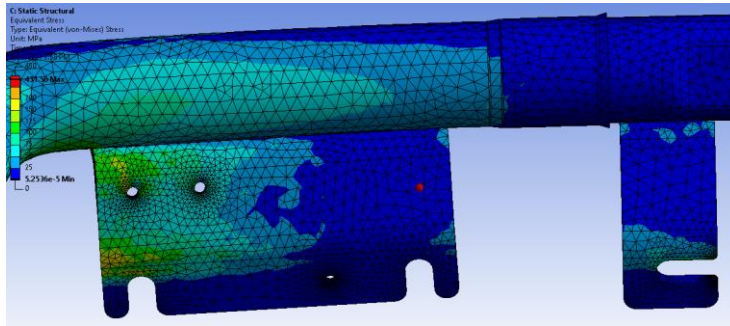
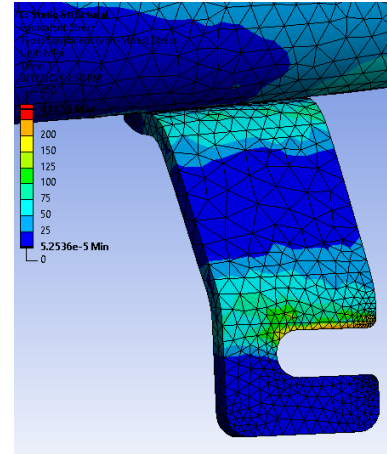
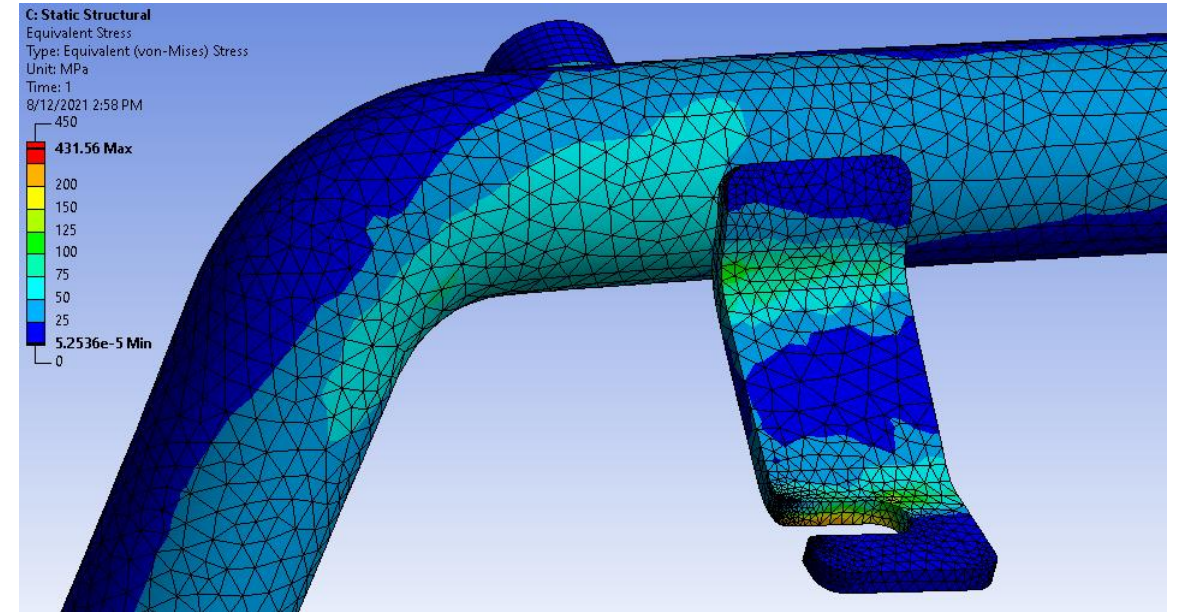
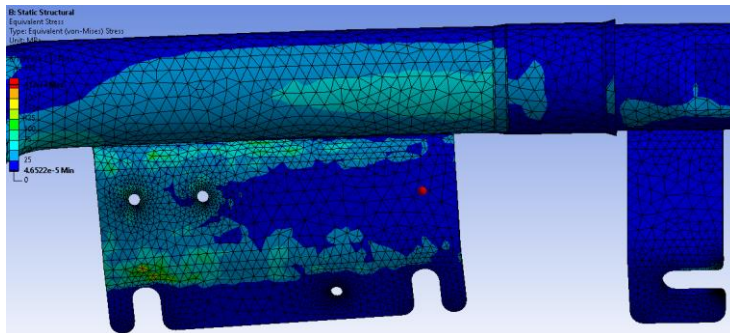
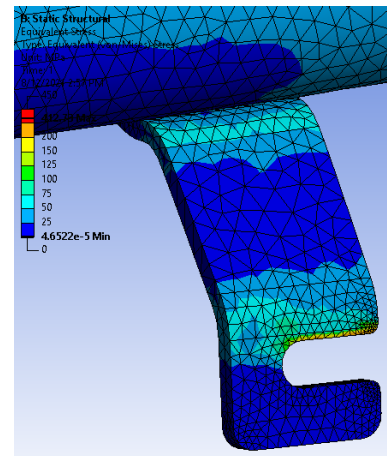
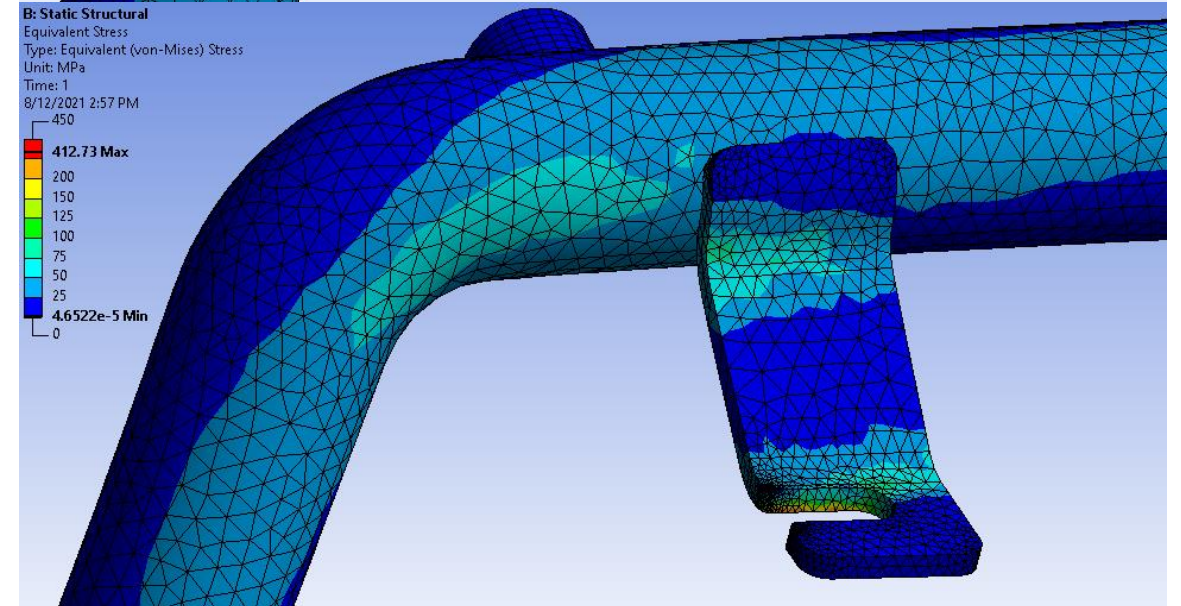
ANSYS Results

- Equivalent stress is lower at each joint with the thinner bracket
- This design change to a thinner bracket:
 - Creates a lower overall load distribution for the same displacement
 - Does not cause more variation in load distribution
 - Does not cause additional stress in any of the welded joints
- This design change is **not** a potential failure mode for any joint
 - Thinner bracket lowers overall loading enough that any shifts in loading distribution do not increase amount of loading at any point
- Loading could be further reduced with thinner long tube brackets (slide #_)
 - The short tube bracket itself is durable despite its 1.5 mm thickness
 - No failures found in the bracket material, only the welded joint
 - Adequate durability also expected for long tube brackets if thickness is reduced

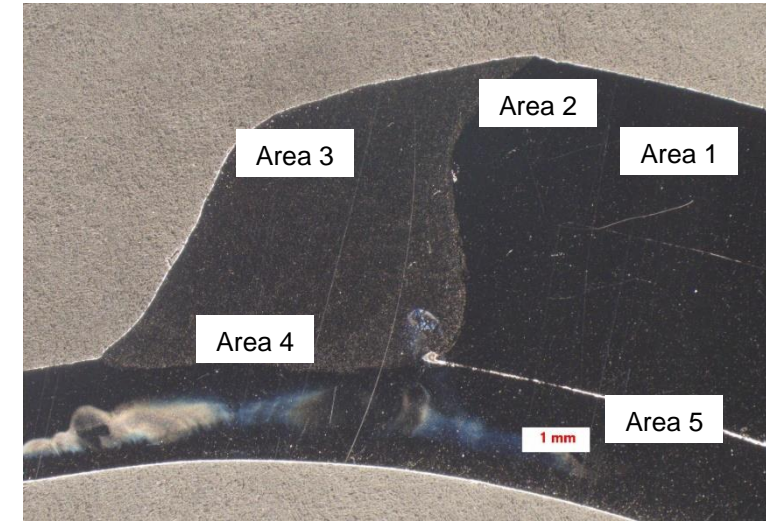
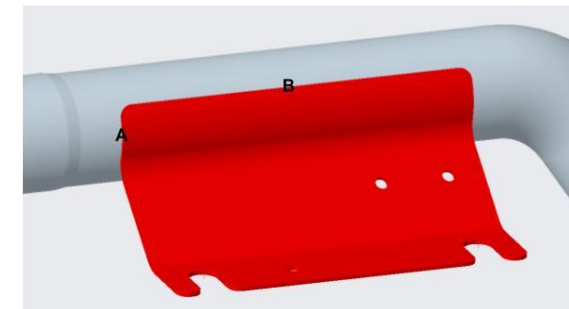
- High hardness leads to low ductility and low fracture toughness
- Excessively low hardness can lead to deformation
- Measured hardness of 3 failed samples at each labeled welded joint:
 - 3 points on the weld
 - 3 points on the base pipe material
 - 3 points on the base pipe material, in the heat-affected zone
 - 2 points on the bracket, both sides (base material)
- Compared hardness results to print specifications
 - Maximum hardness of weldment: 350 HV 500 GF
 - Includes weld, heat-affected zone, and base metal

- No hardness measurements exceed maximum hardness
- No significant difference between new and failed sample hardness values
- Pipe hardness increases at the pipe in the HAZ, expected behavior
- Pipe hardness does not increase at the bracket in the HAZ
 - Potential indication of inadequate weld penetration
- Hardness is highest on the weld, expected
- Long tube average Rockwell hardness meets minimum for material 30125
 - Some long tubes fall slightly below minimum hardness
- Short tube has a lower hardness, material 30048, none below minimum
- Hardness is **not** a primary mode of failure, yet the higher hardness in the HAZ on the pipe makes the material more brittle and therefore susceptible to fracture in the event of deformation due to excess stress

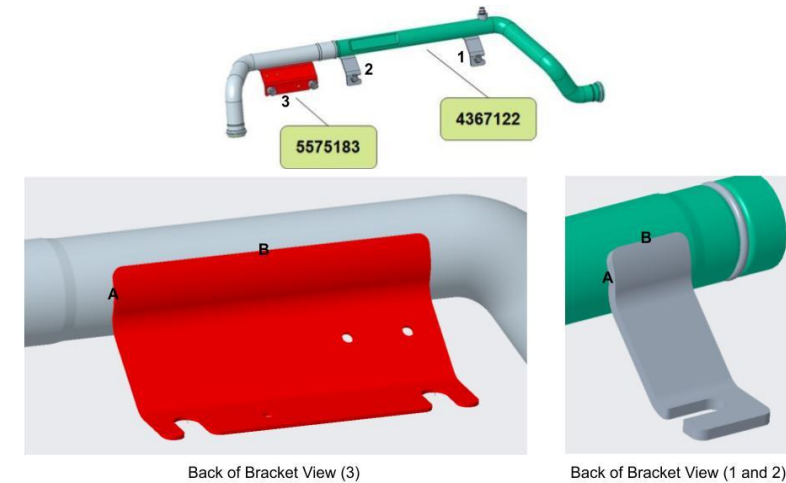
- Inspected weld properties in failed and new samples
 - ISO 5817 standards used to evaluate weld properties
 - Cross-section cut to evaluate each weld
- Evaluated properties: Throat size, porosity, penetration, root fusion
- Multiple imperfections found, **likely modes of failure**
 - Most welds on bracket 1 and 2 do not meet the minimum throat size, 3 mm
 - Root gaps of several welds exceed max limit of 0.6 mm for a 3 mm throat size
 - The larger the root gap, the smaller the area of fusion and the weaker the joint
 - Most welds exceed allowable porosity, 1.5%
 - Some welds have minimal weld penetration, only one critically inadequate weld
 - Clearance between bracket and pipe near weld that can weaken the joint
- Supplier quality issue; contacted suppliers to make changes in weld process

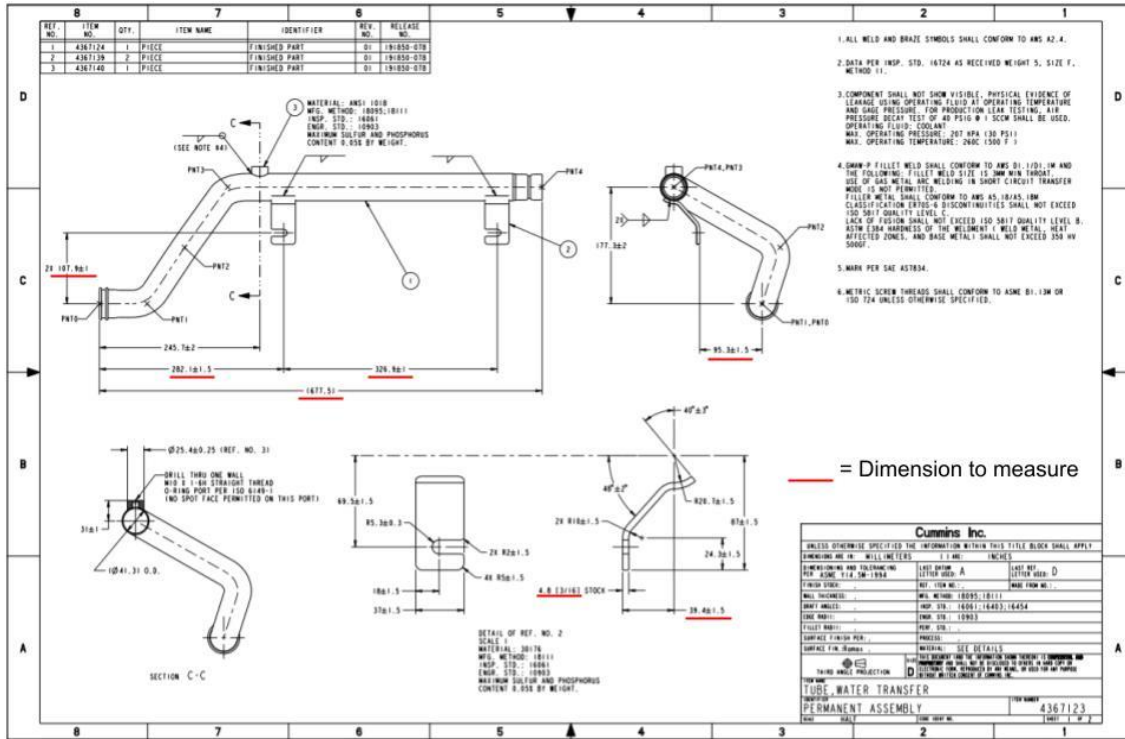
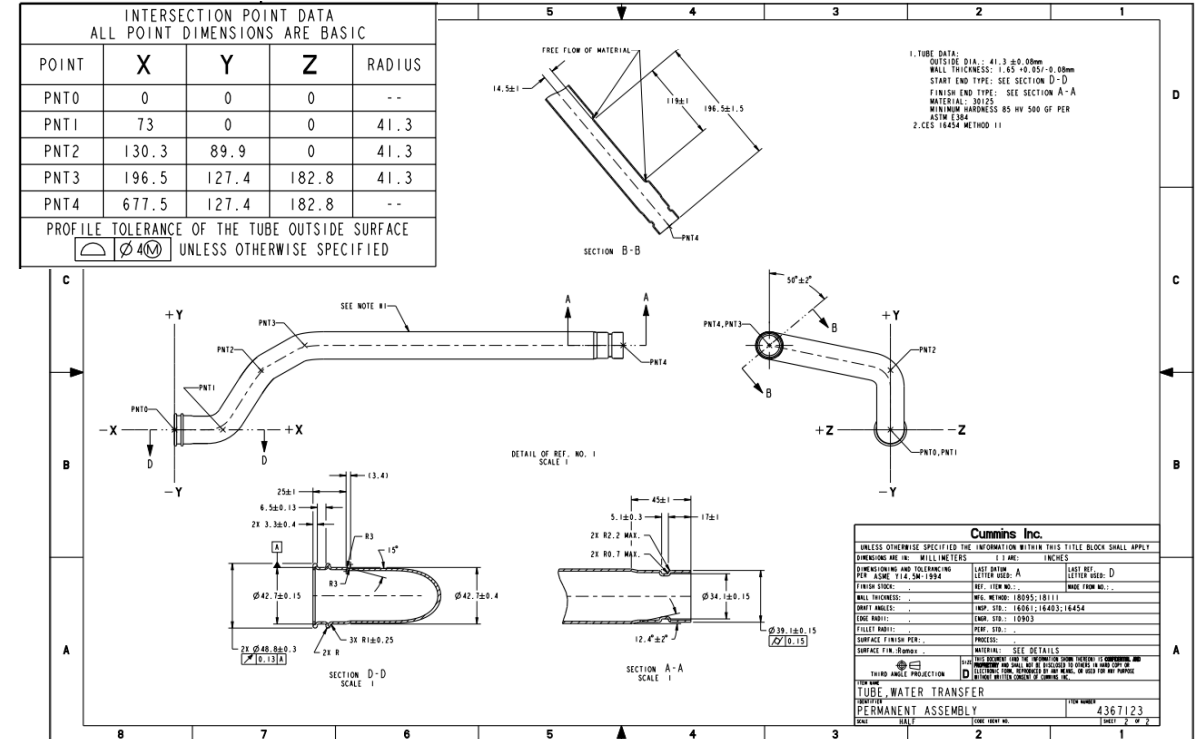
Dimensional Quality – Transfer Tube (Part #4367122)

- Key dimensions for placement of the transfer tube and intersection points
- Dimensions out of tolerance range can cause imperfect fit / internal stress
- 5 new sets of transfer tubes measured and compared to print dimensions

- Consistently failed measurements
 - Intersection point 2 position, all directions, and point 4 position, x direction
 - No bracket positioning failed
- No dimensional variation greater than 0.5 mm between samples
- Failure due to excess static stress from:
 - Dimensional deviation at point 2 is **not** a failure mode
 - Point 2 position is not relevant to how the tubes fit to block
 - Deviation at point 4 x-direction is a **low-likelihood** failure mode
 - Point 4 position has a minor effect on how the tubes fit to block
 - Dimensional variation between parts is **not** a failure mode

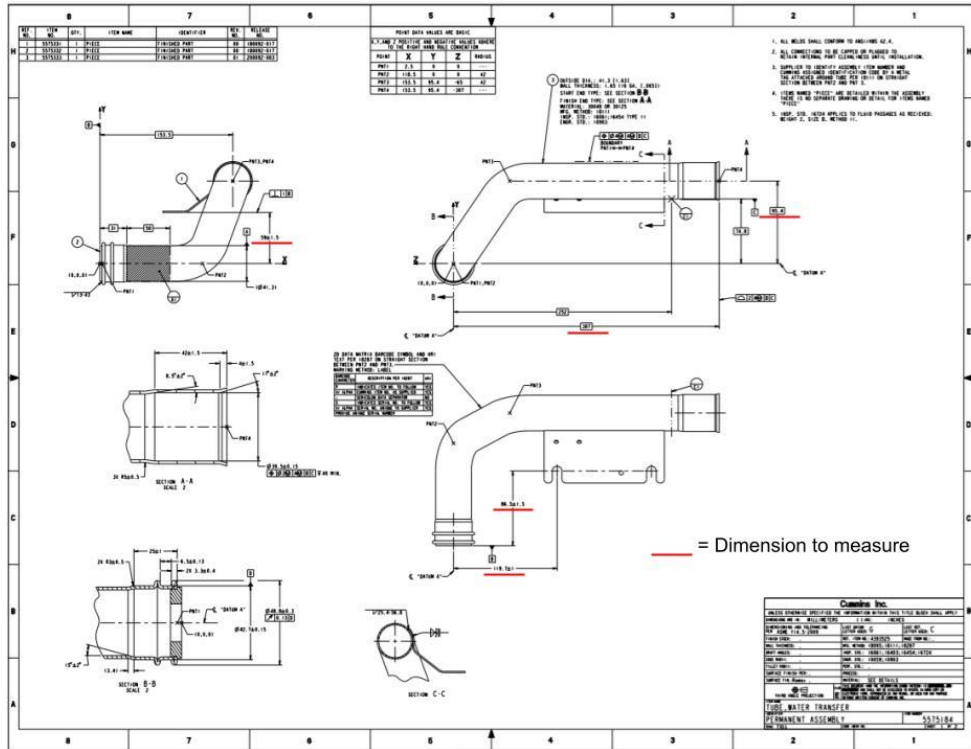
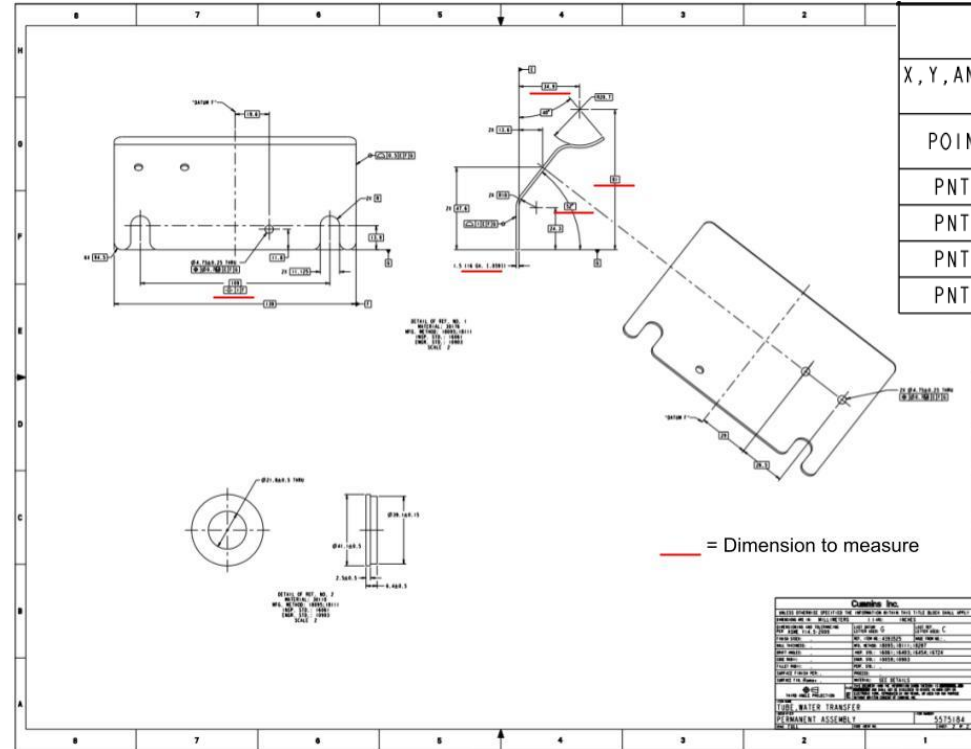
Dimensional Quality – Transfer Tube (Part #5575183)

- Key dimensions of the placement of the tube and bracket dimensions
- Dimensions out of tolerance range can cause imperfect fit / internal stress
- 5 new sets of transfer tubes measured and compared to print dimensions

- Failed measurements
 - All samples failed for either x or z component of point 4 position
 - Sample 3 failed at the bracket angle
 - Did not fail for any bracket positioning dimension
 - 2 samples failed at bracket length and width dimensions
 - However, all samples passed for bracket face to point 1 positioning
 - Same 2 samples also failed at y-direction bracket slot location
- Effect of failed measurements
 - Point 4 position has a minor impact on how the tube fits the block
 - Bracket positioning has a more significant impact on fit
 - Bracket dimensions are not relevant if slot position is accurate

- More dimensional variation than long tube, but none greater than 3 mm
- Failed dimensions are not consistent; different deviations
- Failure due to excess static stress from:
 - Deviation at point 4 any direction is a **low-likelihood** failure mode
 - Point 4 position has a minor effect on how the tubes fit to block
 - Incorrect bracket dimensions is a **low-likelihood** failure mode
 - If these dimensions do not cause incorrect positioning
 - Incorrect bracket position in any direction **is** a likely failure mode
 - Dimensional variation of parts is a **low-likelihood** failure mode

- Dimensional quality issues
 - 5575183 bracket out-of-tolerance dimensions, inform supplier
 - If fit is an issue once dimensions are fixed, evaluate print dimensions
- Weld quality issues
 - 4367122 supplier has not yet responded to SQIE, follow up
 - Have supplier evaluate weld application process that may cause quality issues
- Static/dynamic stress analysis
 - Repeat test cell strain gauge operation for part with dimensional quality issues and compare to initial results if needed to determine severity of these issues
 - Validate durability of 1.5 mm long tube bracket thickness change
 - Cost justify with quote from supplier, create CTR -> CR to make this change

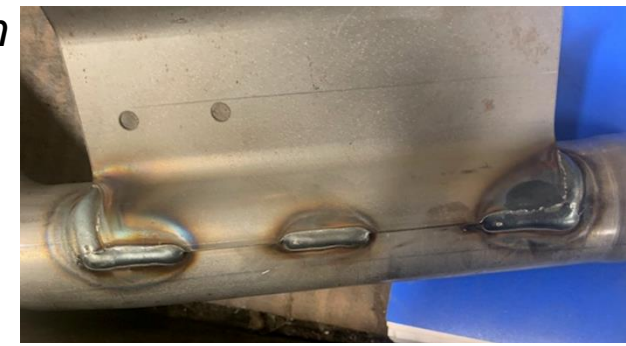
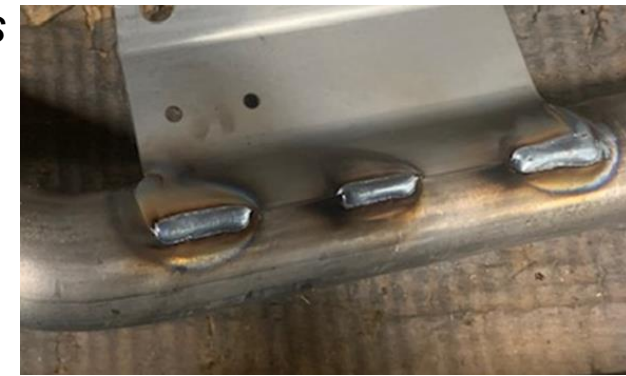
SQIE Solution – 5575184 Weld Quality

- Weld supplier quality issues – weakened weld joint
 - Excess weld porosity, > 1.5% common
 - Weld throat size does not meet the 3 mm minimum on some 4367122 parts
 - Root gaps exceed allowable 0.6 mm length
 - A few cases of inadequate weld penetration
- Hardness in pipe heat-affected zone greater than base material hardness
 - Expected behavior, but this is a factor that may cause failure at the joint before the pipe if the failure mode is some form of excess stress
 - Supplier test confirmed that joint location fails with less vibrational loading

- 5575184 supplier: [REDACTED]
- Weld heat increased to ensure adequate weld penetration
 - Still within specified WPS parameters
 - Hardness testing to confirm no significant change
 - Did a “runout” to ensure no burnthrough or undercut
- Torch position and work angles changed in welding robot program to eliminate ropey appearance – perpendicular weld application
- Dye penetrant testing conducted to ensure no undercut or cracking issues
- Evaluated fixturing between bracket and pipe to ensure correct placement
- Reviews conducted for use of anti-spatter and cleaning operations
- Communicated changes and expectations with welders/operators, quality control, engineering, and production management

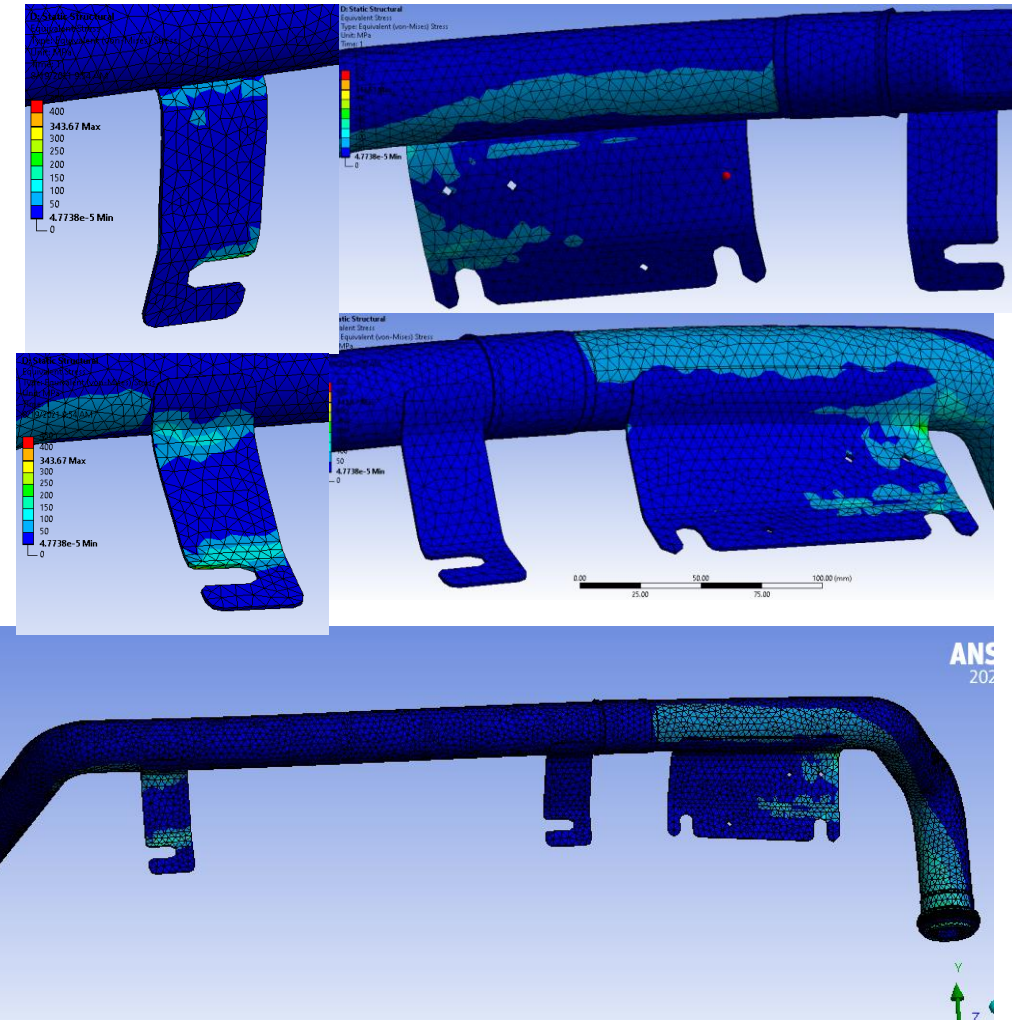
Design Solution – High Static / Dynamic Stress

- ANSYS static stress analysis on system with 1.5 mm 4367122 brackets
 - Compared to results from current system with 4.8 mm 4367122 brackets
 - (Slide #_)
 - Stress distribution is lower in 1.5 mm 4367122 bracket system at every location
- Cost justification needed
 - Tooling cost will be present
 - Piece part cost reduction likely
