End of Co-op Presentation

By: Jessica Nicholson

Water Transfer Tube Weld Cracking Investigation

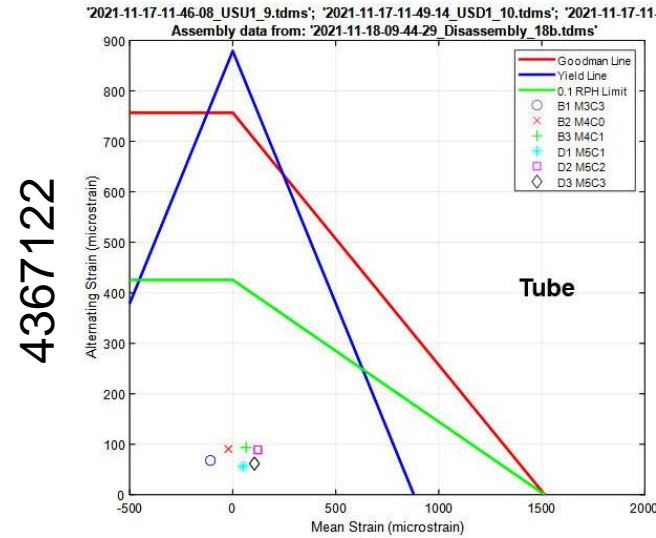
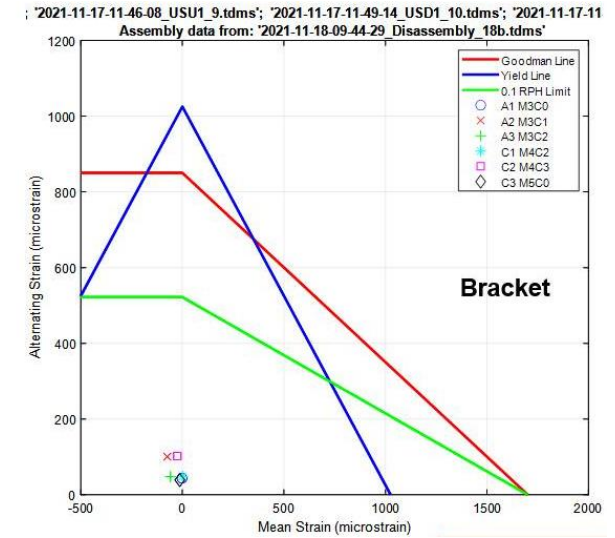
- Strain gauge engine operation
- Measured set of transfer tubes
- Static, mean, alternating stress
- Low + high idle, loaded, unloaded
- Not a failure mode

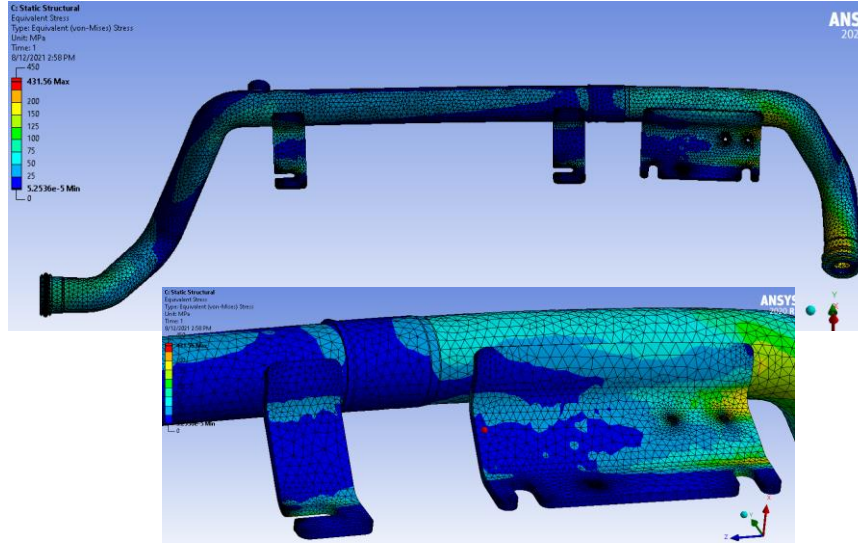
Old
Bracket:
4.8 mm

- Two ANSYS simulations performed for 1.5 and 4.8 mm bracket thicknesses
 - Given displacement perpendicular to each bracket face = 1 mm
 - Same fixed support points at both ends of transfer tubes
 - Both full-system simulations measure equivalent stress
- Locations of interest – each welded bracket-to-pipe joint
 - Stress measured at these locations; stress distribution shown
 - Stress distribution compared between simulations

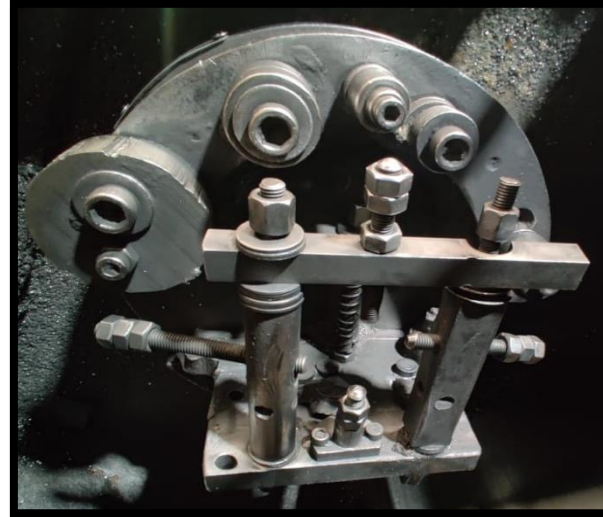
Manual Clamping Production Method

- Connector supplier: Mahabal Metals
- 3 hydraulic and 1 manual clamping mechanism in each CNC machine
- Manual clamping mechanism identified as cause of dimensional issues
- Replaced manual clamping mechanism with hydraulic clamping mechanism
- Should significantly reduce error in positioning from manual mechanism

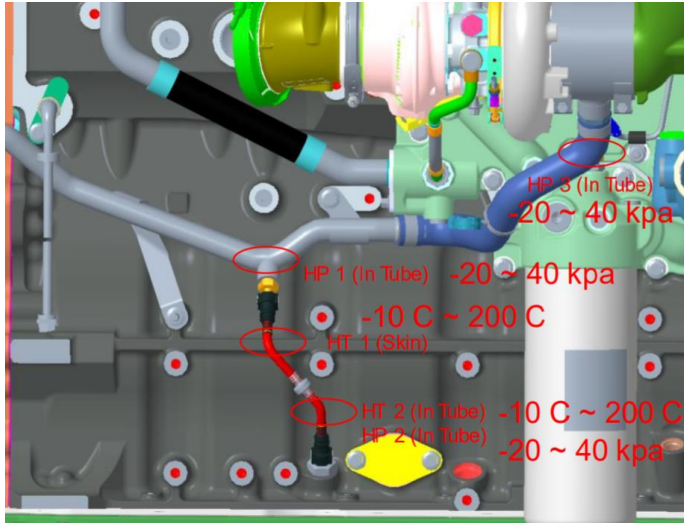
10/27 1:30 PM

- Internal operating pressure and temperature gauges
- Peak measured operating temperature = 130 C
- Measured internal operating pressure at each gauge location
- Pressure measurement observations
 - Pressure in drain tube above check valve is negative
 - Pressure in below check valve averages 0 kPa
 - Check valve opens:
 - To allow drainage when internal pressure above check valve rises or below drops
 - When pressure within the tube above the check valve exceeds the pressure below

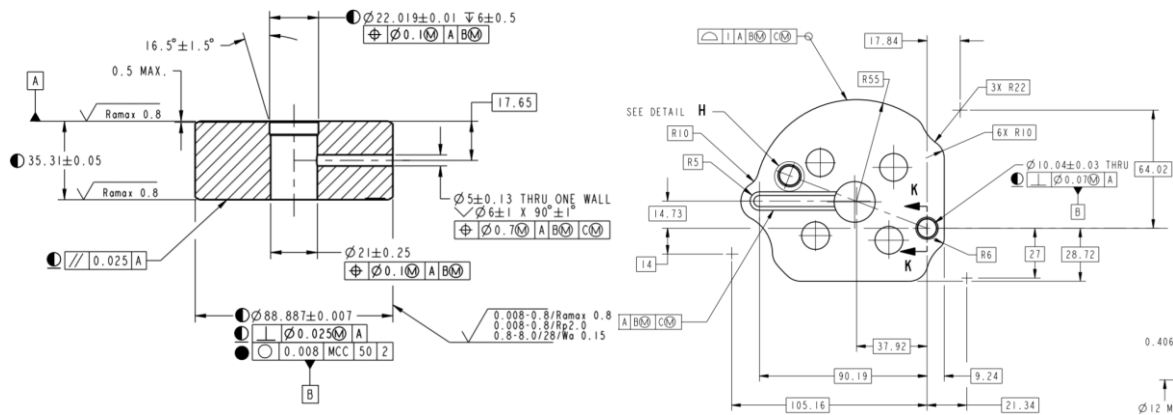
Single Cam Components

- Retained austenite within dual-cam UIG idler shaft transitions into martensite over time with preload applied to bolts
 - Martensite formation causes diameter increase
 - Clearance between idler shaft and bushing narrows
 - Hydrostatic oil film narrows and eventually closes
 - Lack of oil film causes system failure
- Field return vs new part diameter measurements
- Heat treatment procedure altered for single-cam system to decrease retained austenite
 - Original = 350 F – 90 mins, New = 400 F – 90 mins
 - CTR 4120261 – 19% radial growth decrease

- **Replace dual-cam idler shaft** with the single-cam system UIG idler shaft
- Will prevent the dual-cam UIG idler shaft from generating martensite
- Apply change as a service part replacement, not production
 - Commonized UIG idler shaft for both systems in service
- Geometry and compatibility of both idler shafts
 - No need to redesign single-cam idler shaft or dual-cam system components
